LATOSKY INSPECTION & ENVIRONMENTAL SERVICES, LLC
INSPECTION REPORT

PART ONE

BACKGROUND DATA

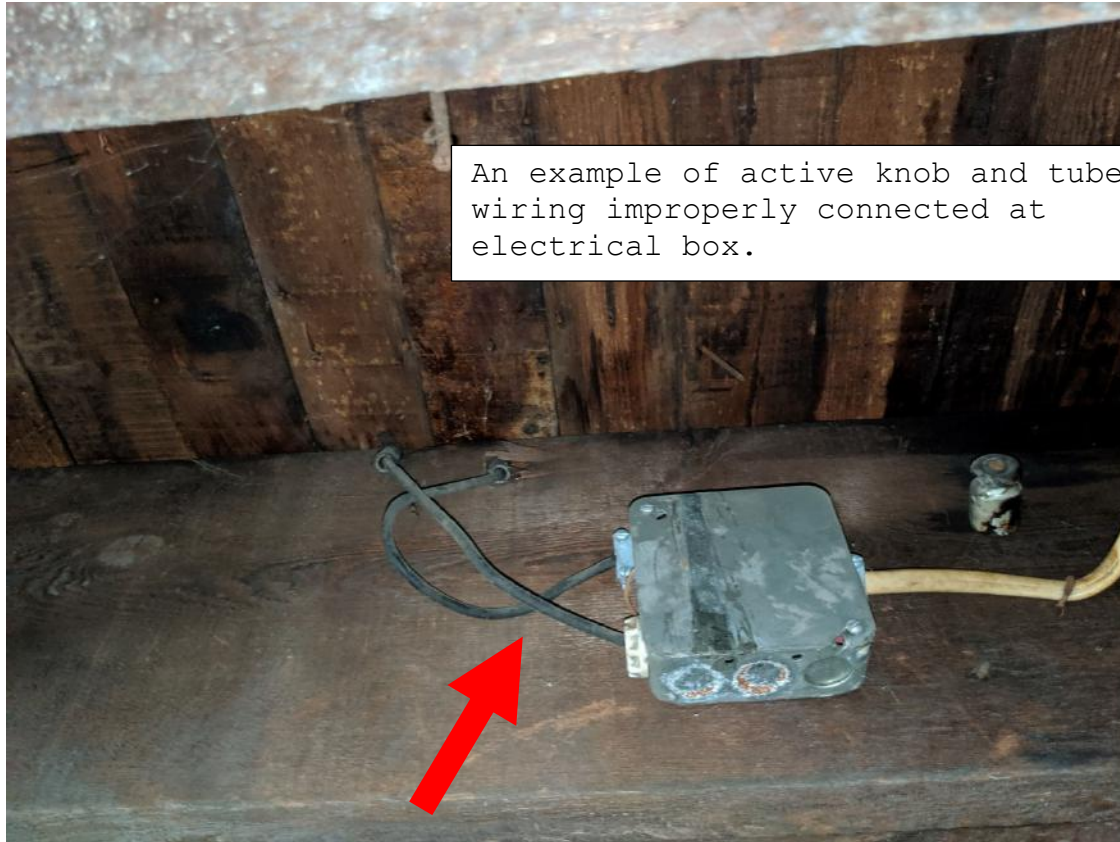
An example of active knob and tube wiring improperly connected at electrical box.

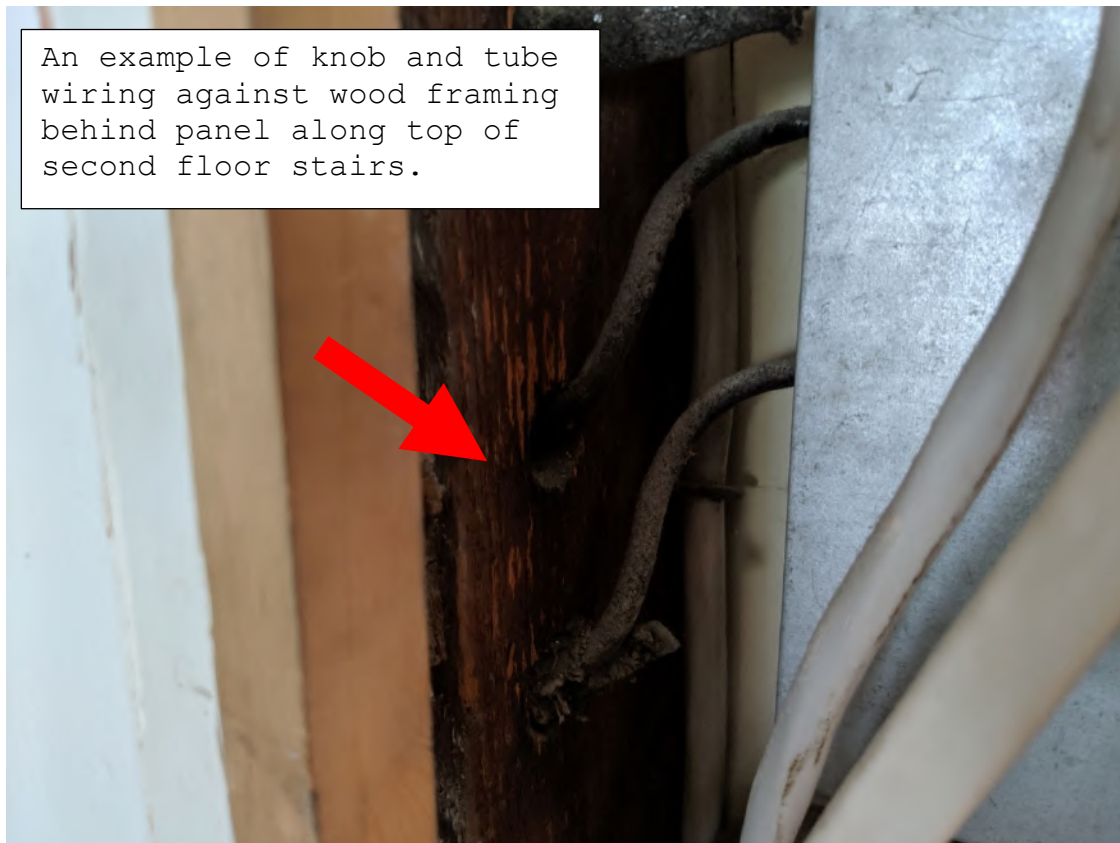
An example of knob and tube wiring against wood framing behind panel along top of second floor stairs.

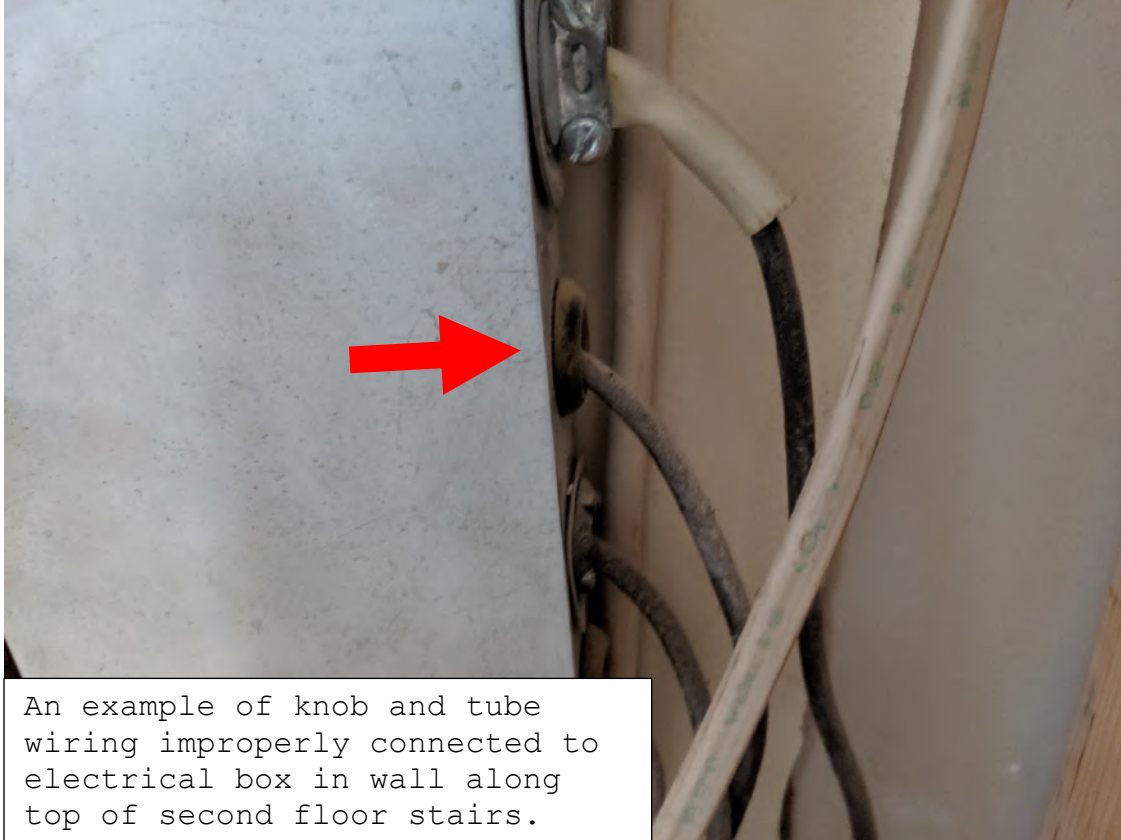
An example of knob and tube wiring improperly connected to electrical box in wall along top of second floor stairs.

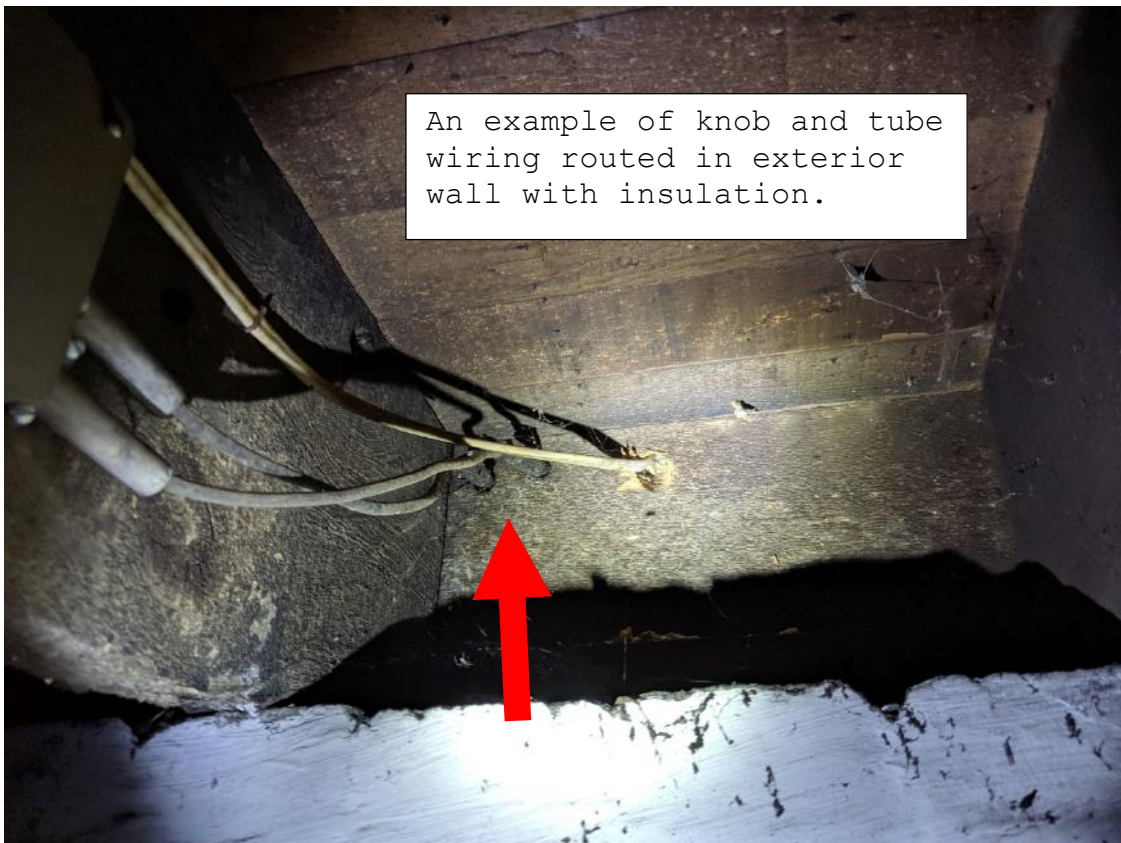
An example of knob and tube wiring routed in exterior wall with insulation.

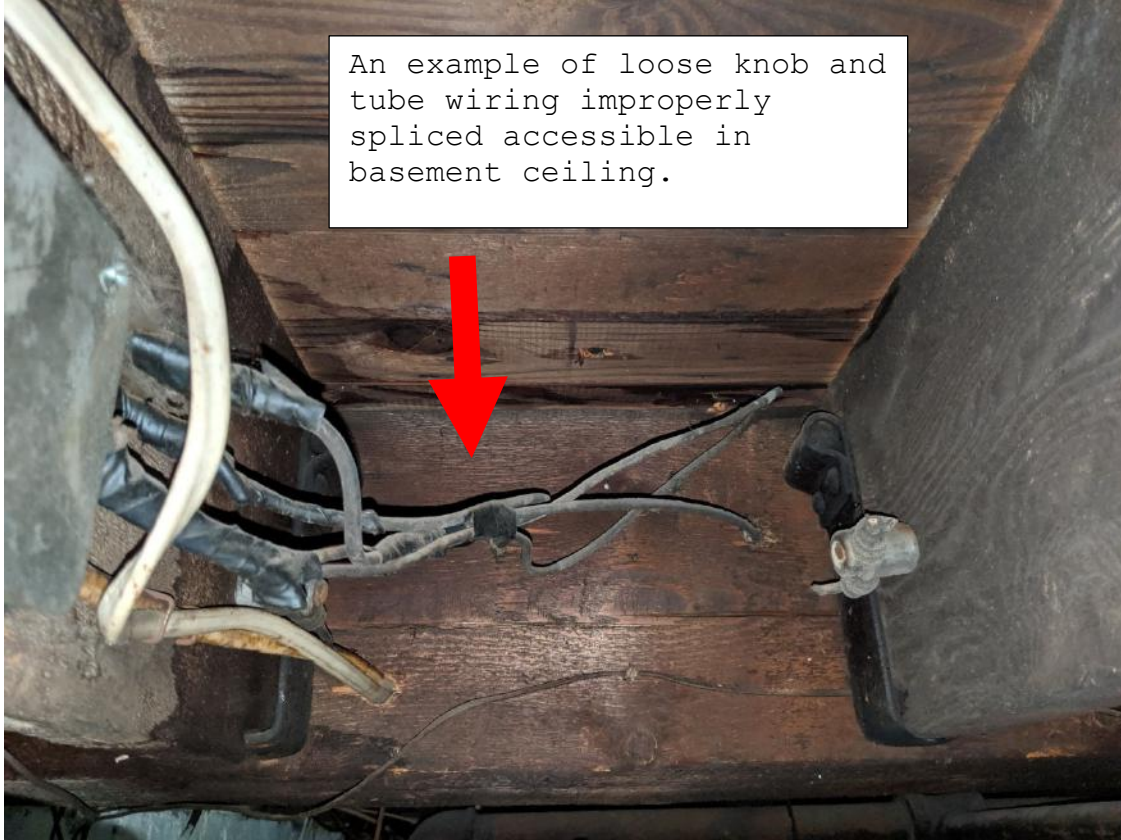
An example of loose knob and tube wiring improperly spliced accessible in basement ceiling.

An example of loose knob and tube wiring connections at electrical box in basement ceiling.

Typically, it is necessary to replace knob and tube wiring where it is an issue. It is recommended that a qualified professional electrician be called in to evaluate the electrical system and to make the necessary repairs in accordance with prevailing electrical standards to ensure a safe and working system.

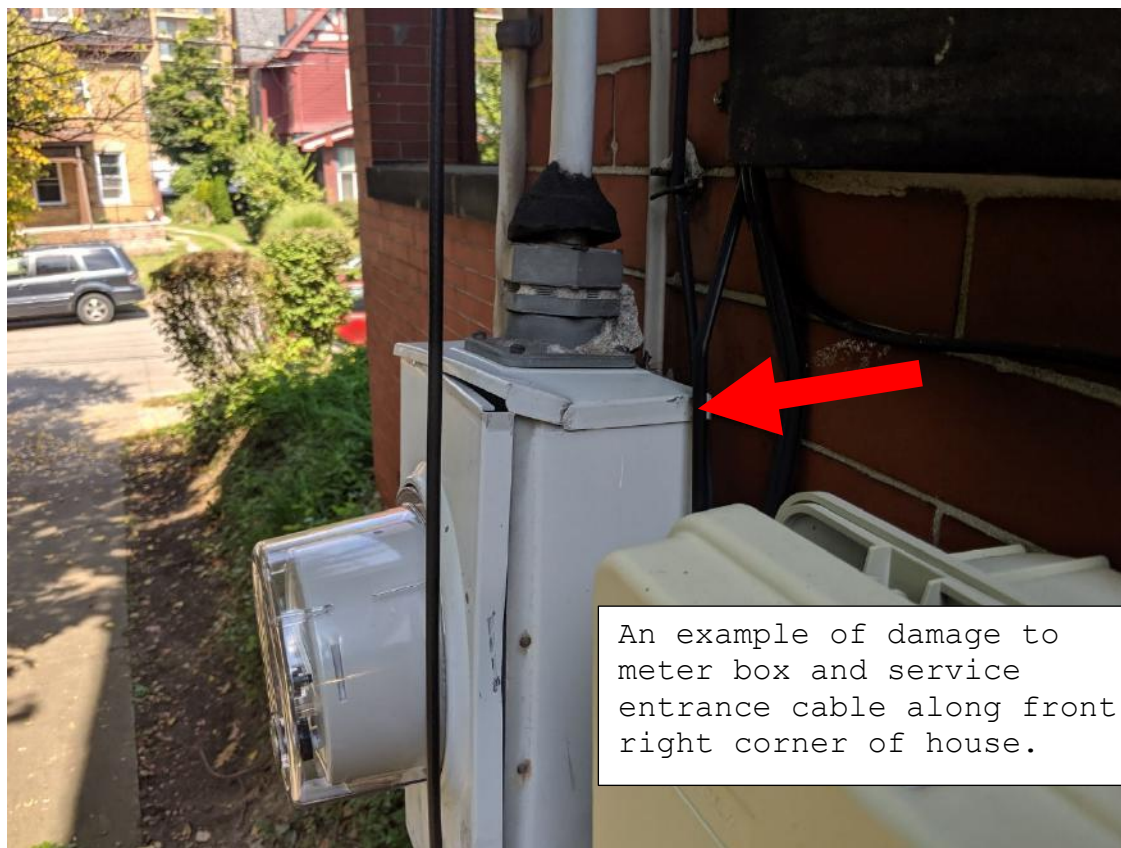
The electric meter and service entrance cable outside along the right side of the house have been damaged. It appears that a vehicle had run into the meter and pulled it and the electrical service cable from the house. The damaged service equipment is a safety issue. Have the electrician further evaluate and replace as necessary.

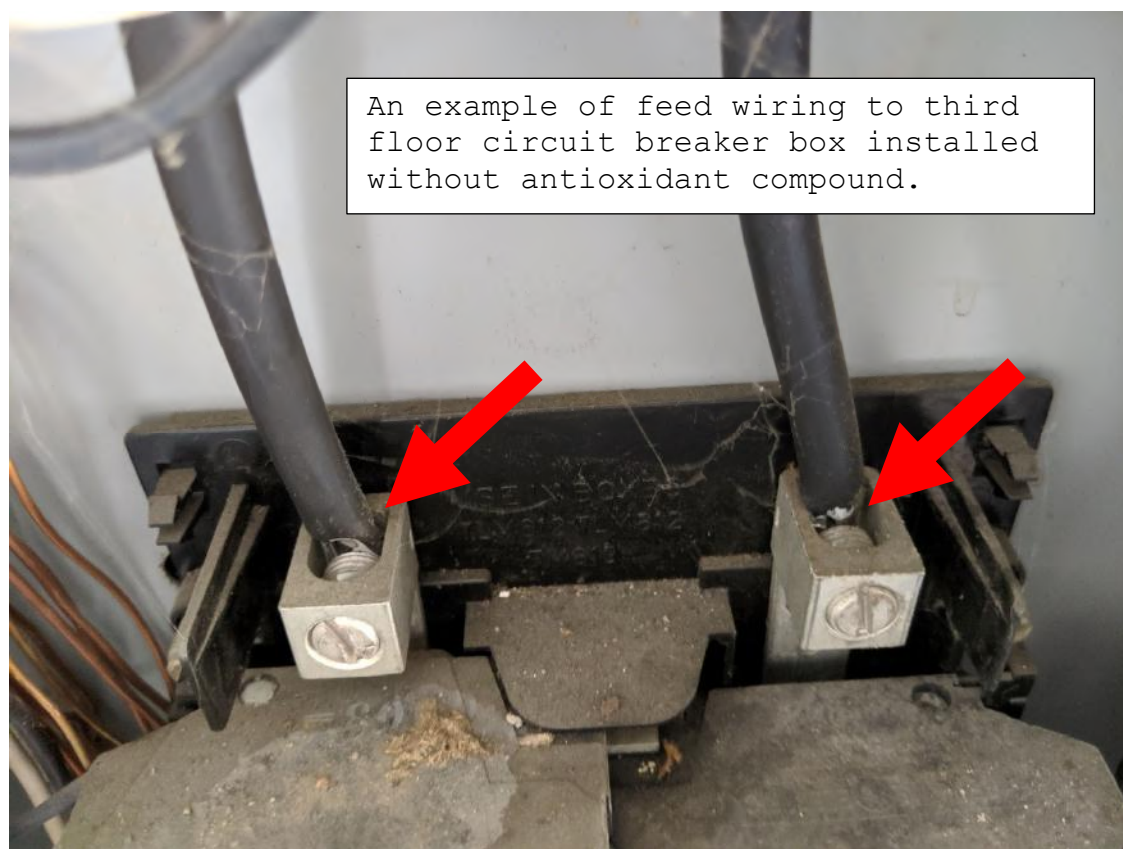
The feed wires to the third floor circuit breaker box were not installed with an antioxidant compound to ensure a good connection and prevent corrosion. Have the electrician evaluate this installation and have an antioxidant applied to these connections as necessary.

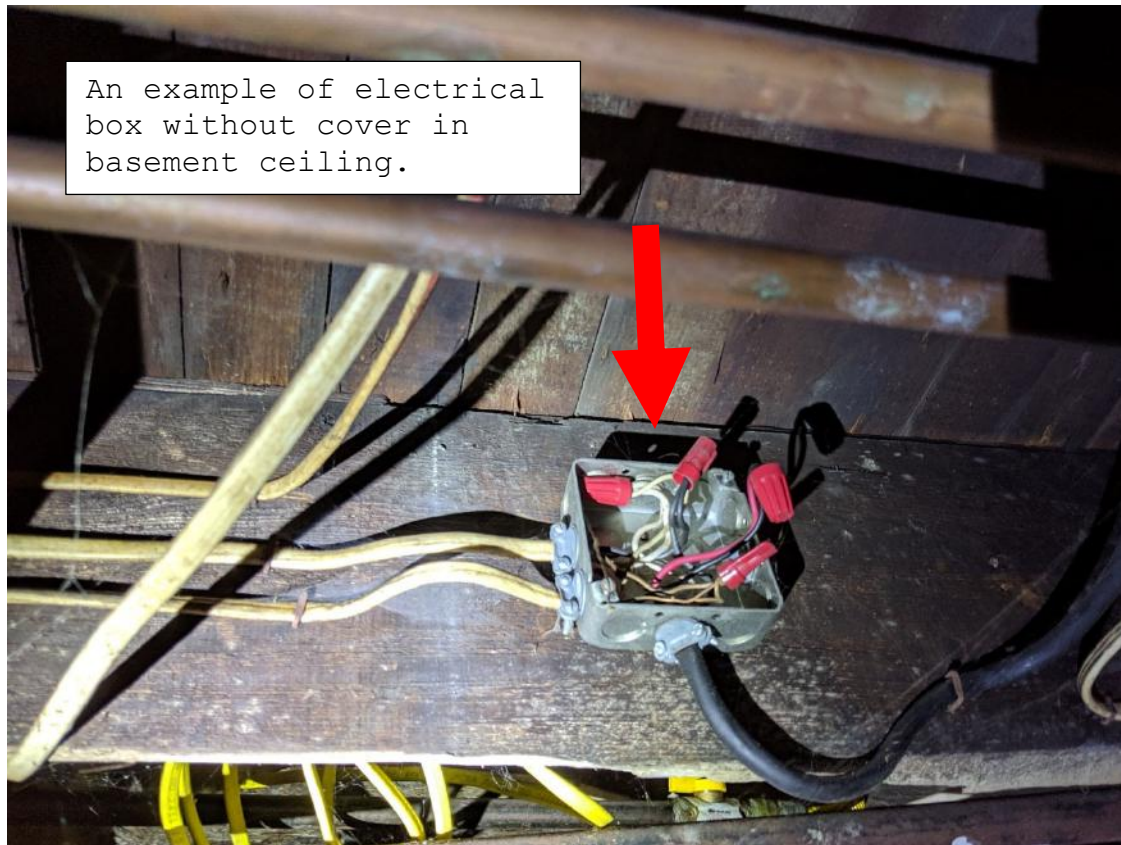
There are electrical boxes accessible in the basement and attic space that do not have covers. All electrical boxes should be properly fit with covers in accordance with prevailing electrical standards.

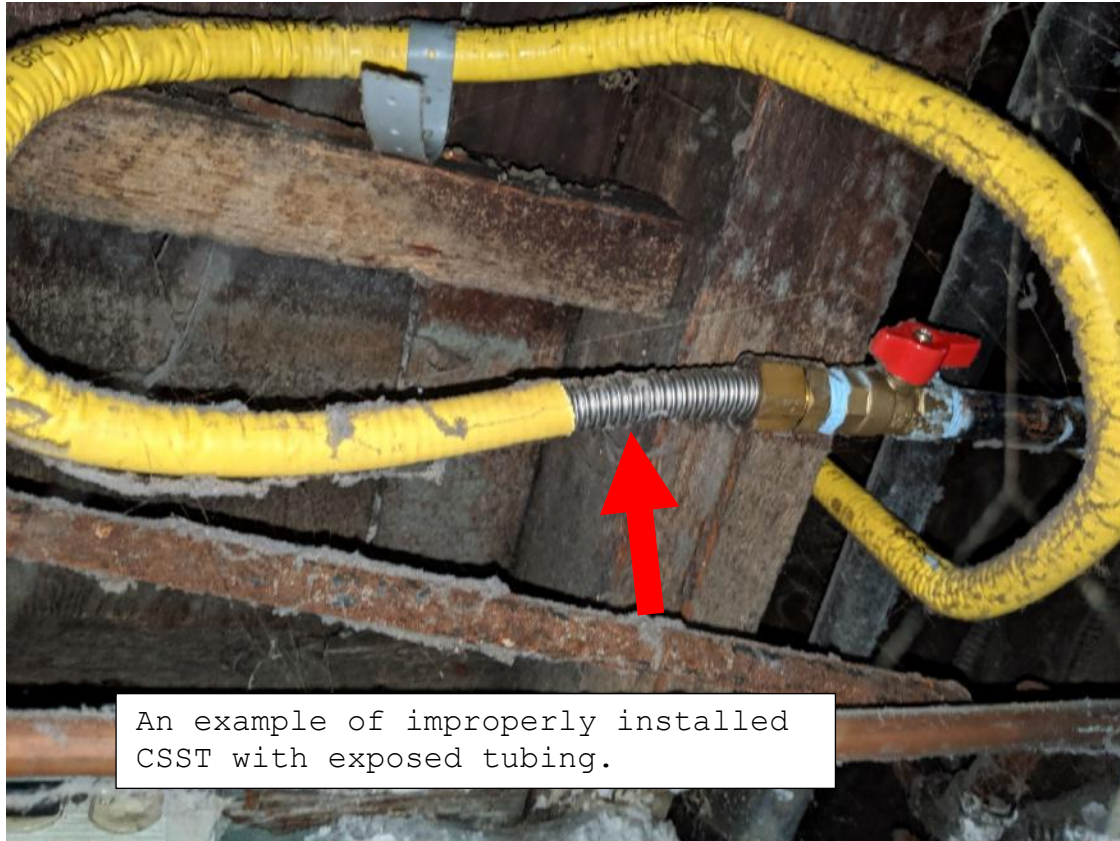
Also, note that outer protective jacket on the tubing was improperly cut back to far in the basement ceiling above the clothes washing machine and dryer and the tubing was overly bent. The inner corrugated tubing is exposed. Have a qualified professional installer in to repair as necessary in accordance with manufactures installation standards.

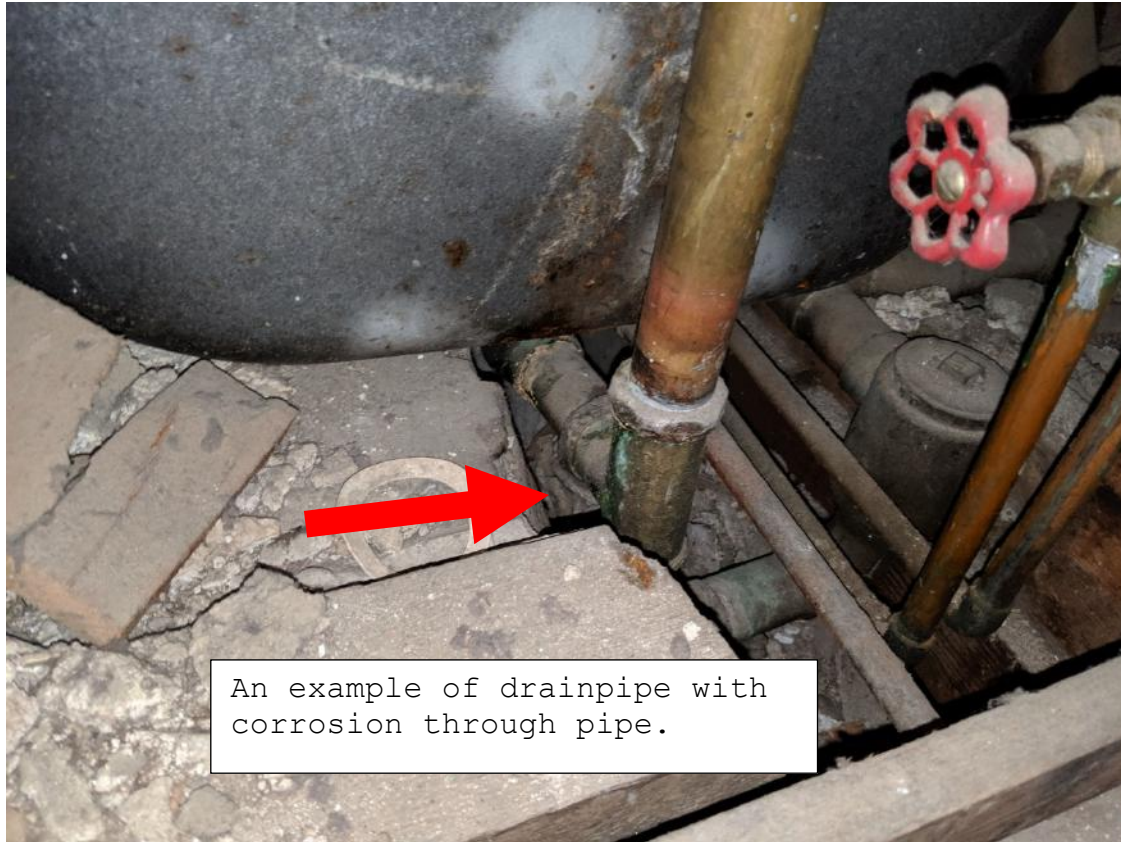
The drainpipe under the second floor hallway bathroom tub that is accessible in the plumbing access has corroded through. The drainpipe should be evaluated by the plumber for replacement.

An example of drainpipe with corrosion through pipe.

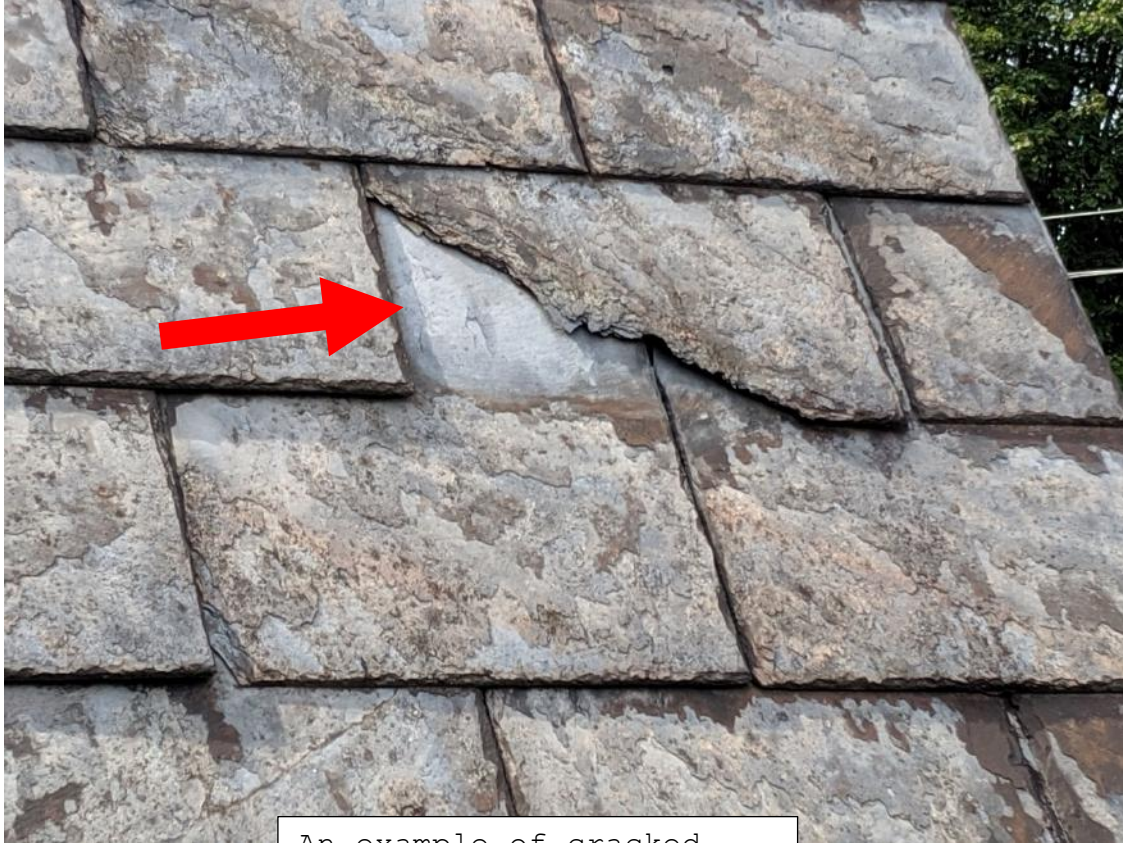
There are over a dozen slates that have slid out of place, cracked or are missing and need repaired or replaced.

An example of cracked and missing shingles.

It is recommended that a qualified professional slate roofing contractor be called in for further evaluation of the roof and to provide the necessary repairs. Note the costs of repairs are expected to be significant.

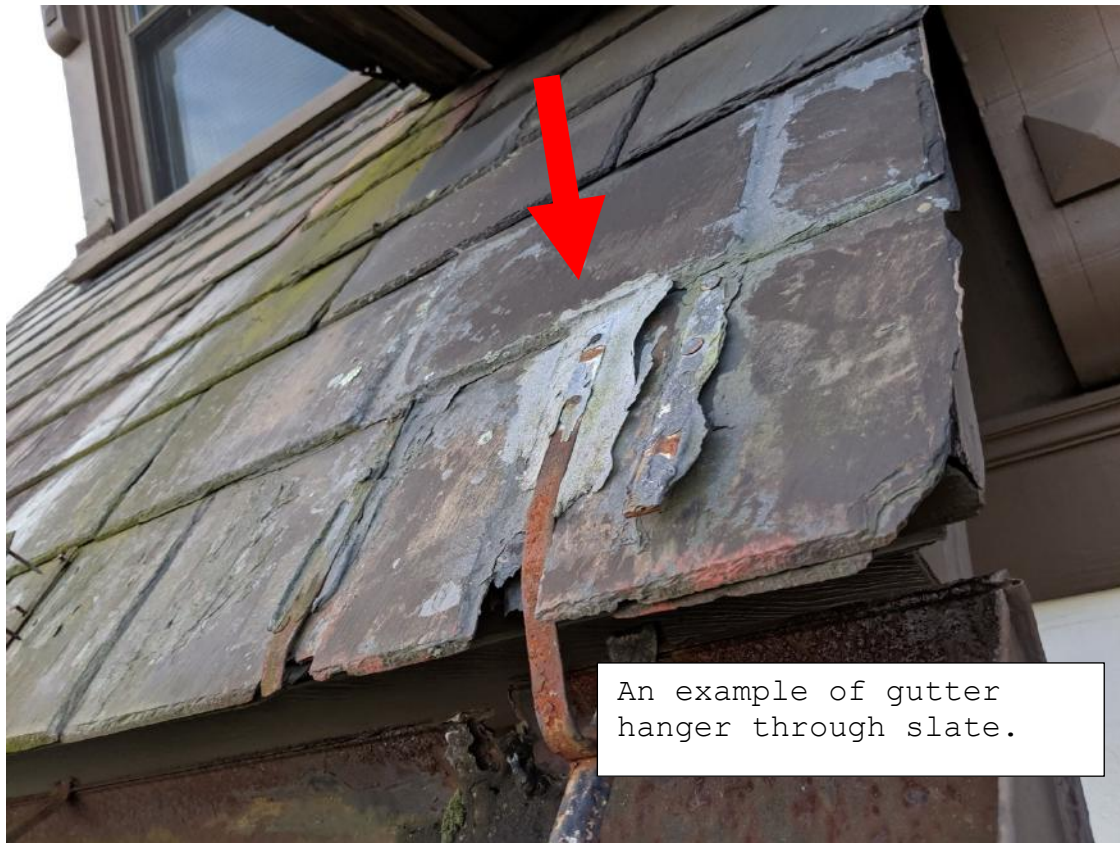
The gutters were hung from the roof with hangers and exposed nails installed through the slates. The holes through the slates were sealed with tar and the tar is cracked and failing.

An example of gutter hanger through slate.

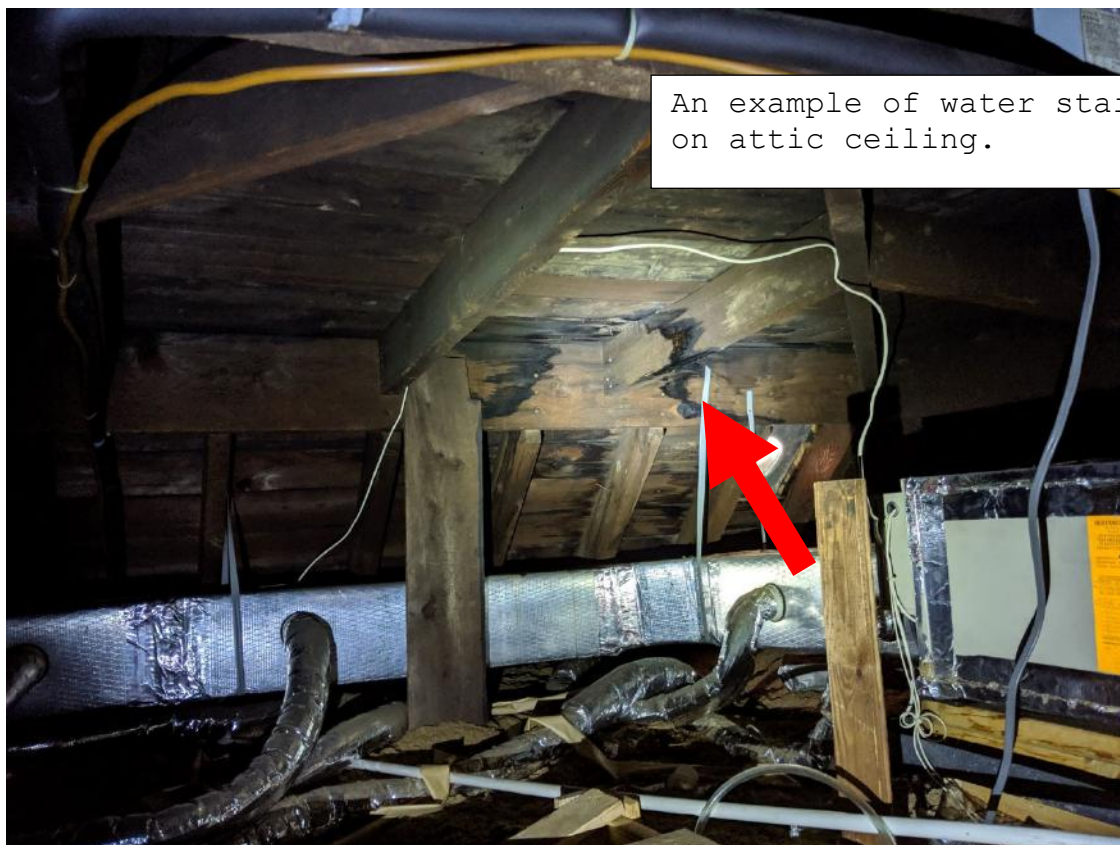
An example of water stain on attic ceiling.

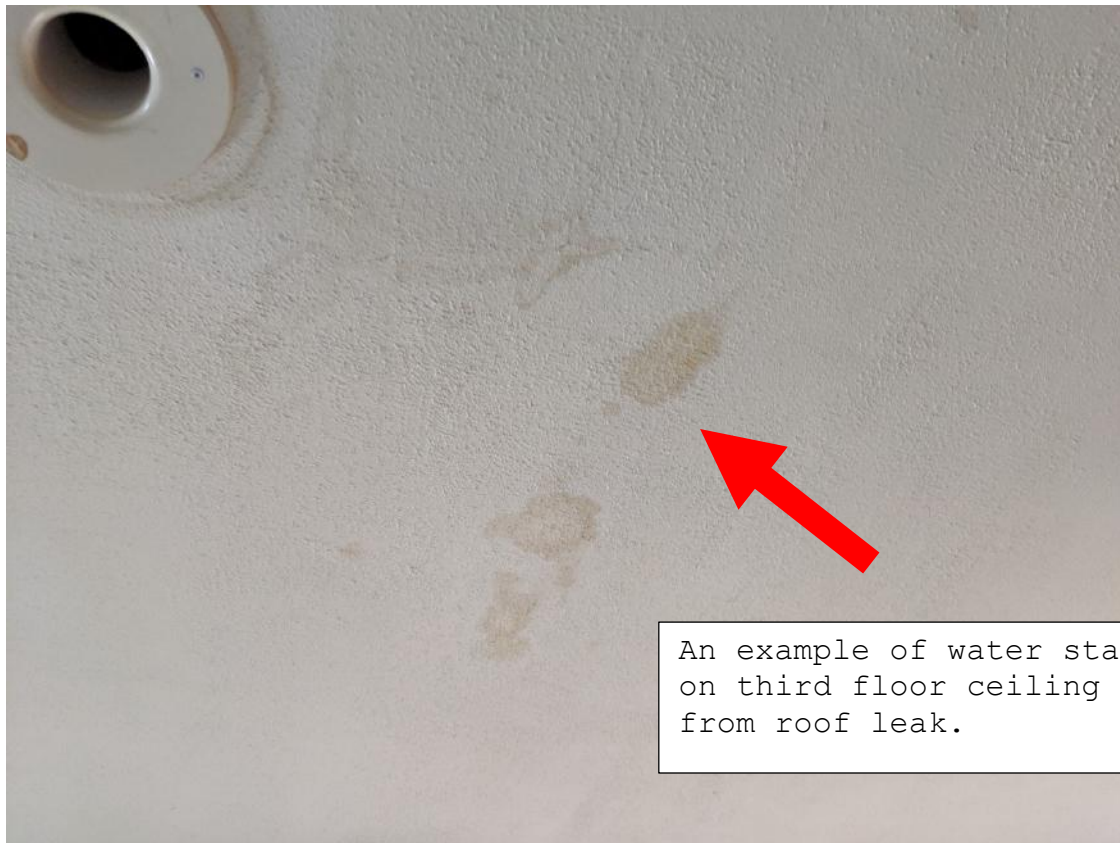
An example of water stain on third floor ceiling from roof leak.

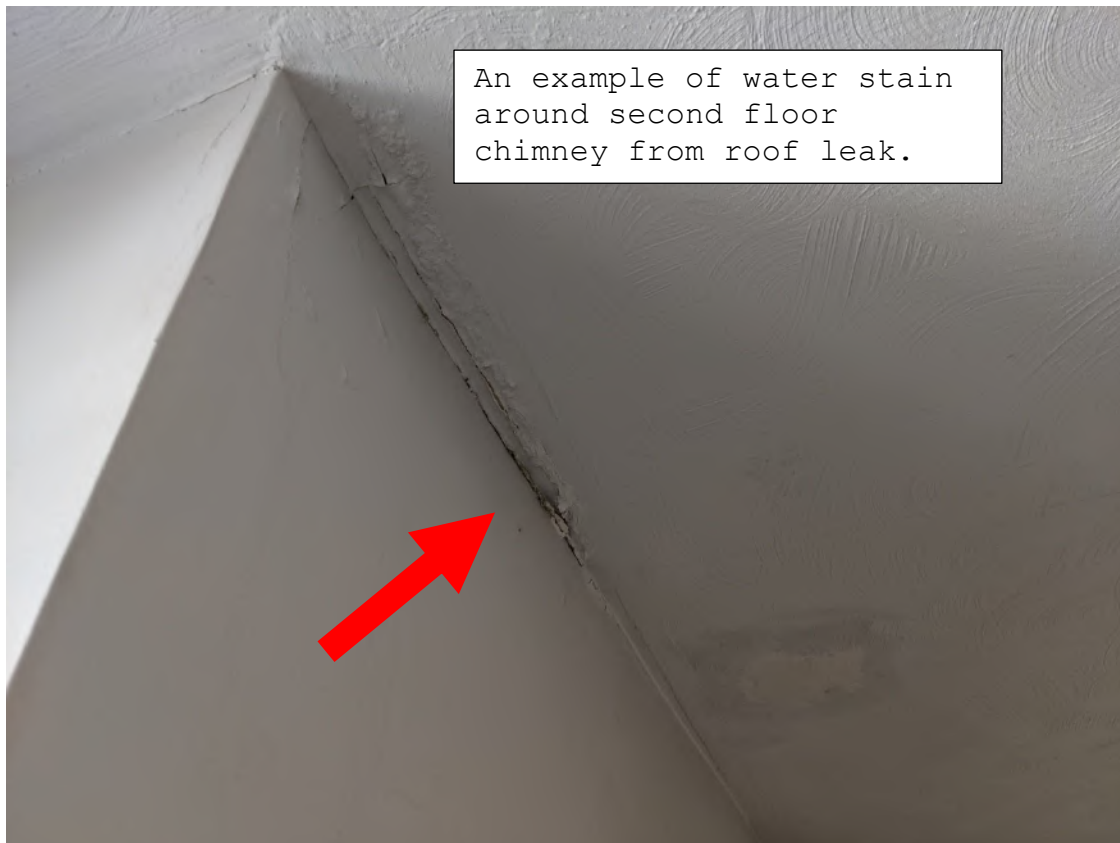
An example of water stain around second floor chimney from roof leak.

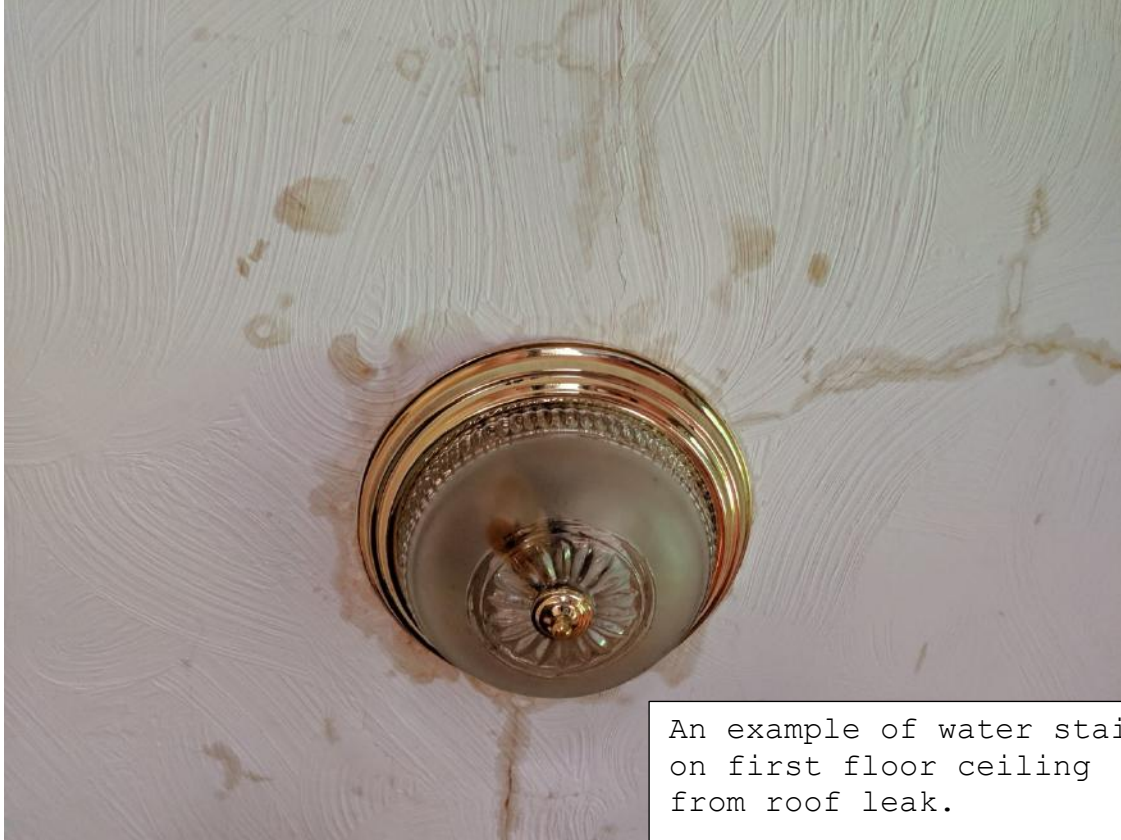
An example of water stains on first floor ceiling from roof leak.

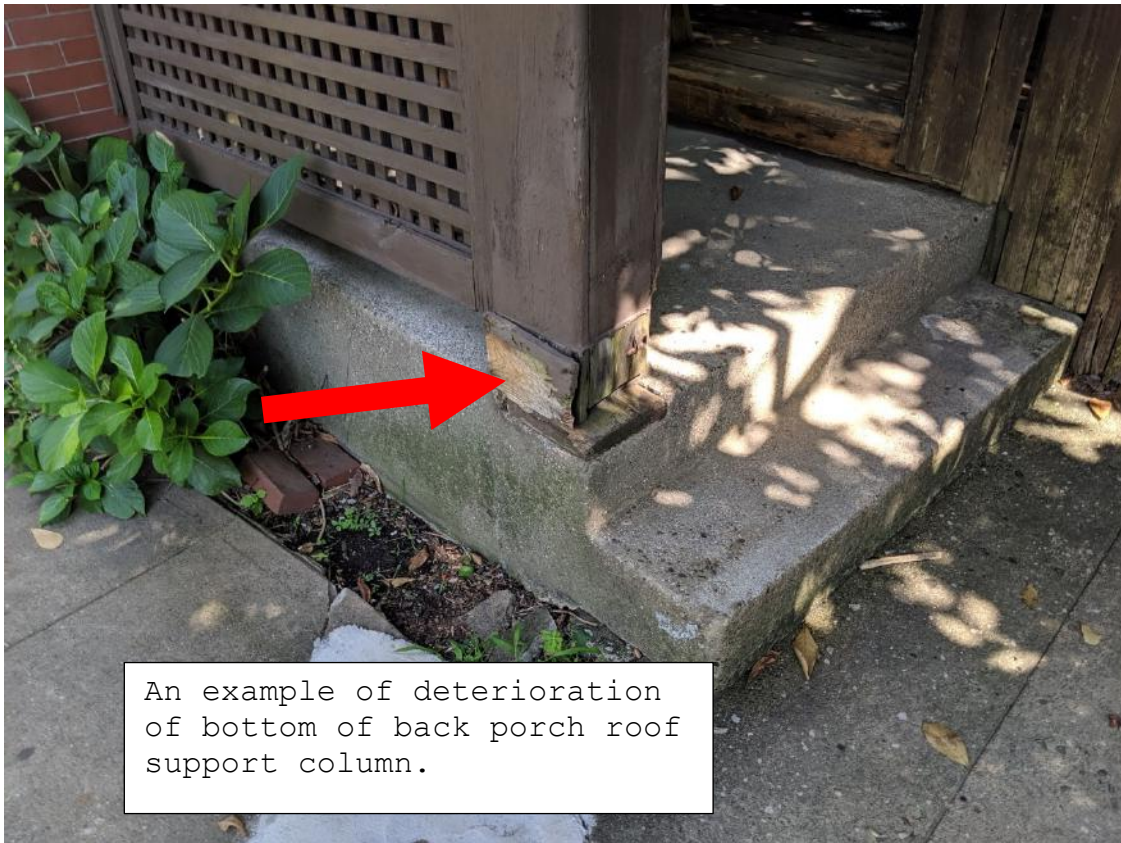
An example of deterioration of bottom of back porch roof support column.

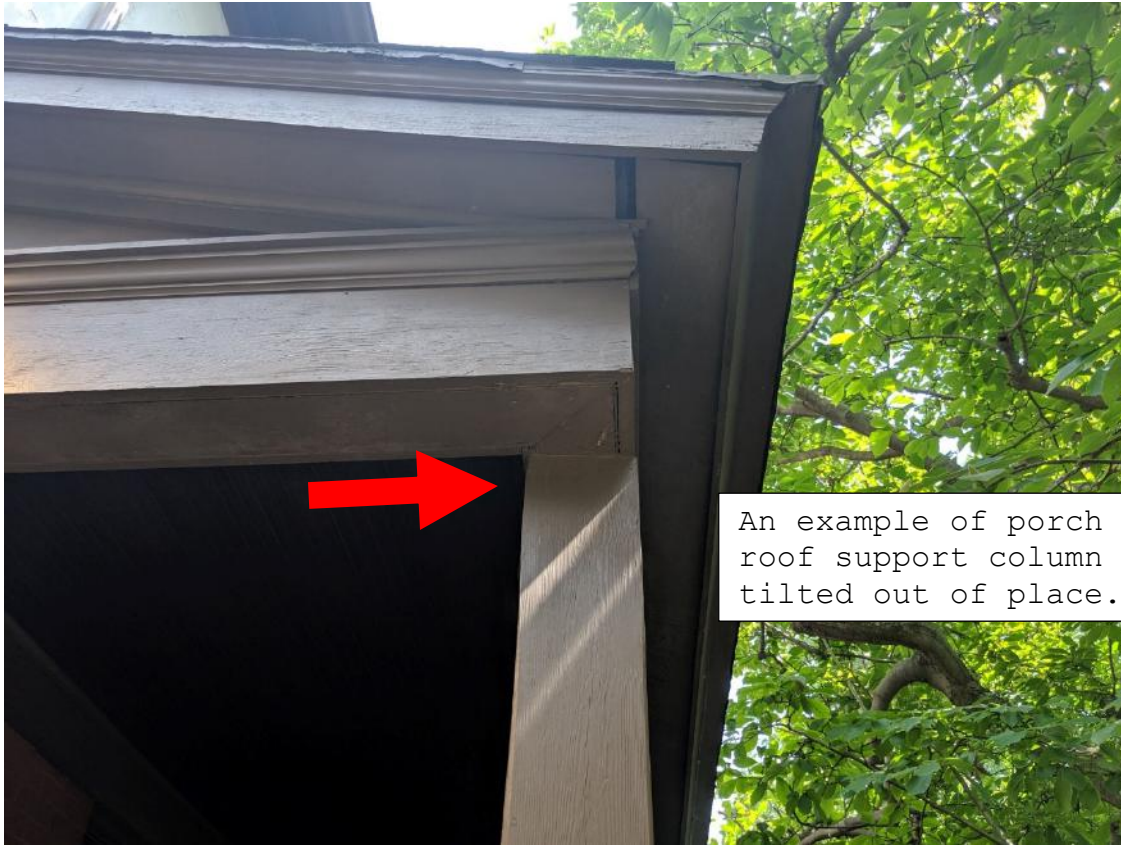
An example of porch roof support column tilted out of place.

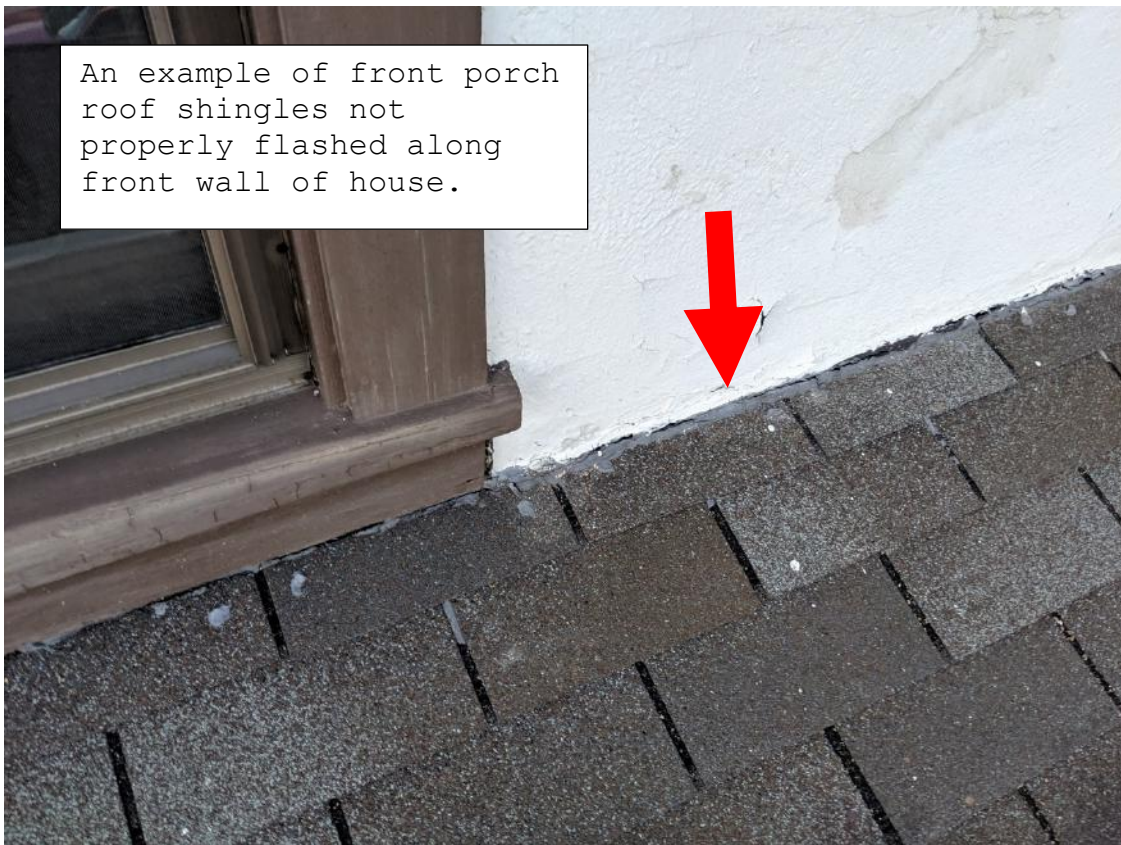
The front porch roof shingles were not properly flashed along the front wall of the house. The joint between the shingles and front wall of the house was temporarily sealed with caulk and the caulk is cracked and gapping. Have the roofer evaluate and repair as necessary.

An example of front porch roof shingles not properly flashed along front wall of house.

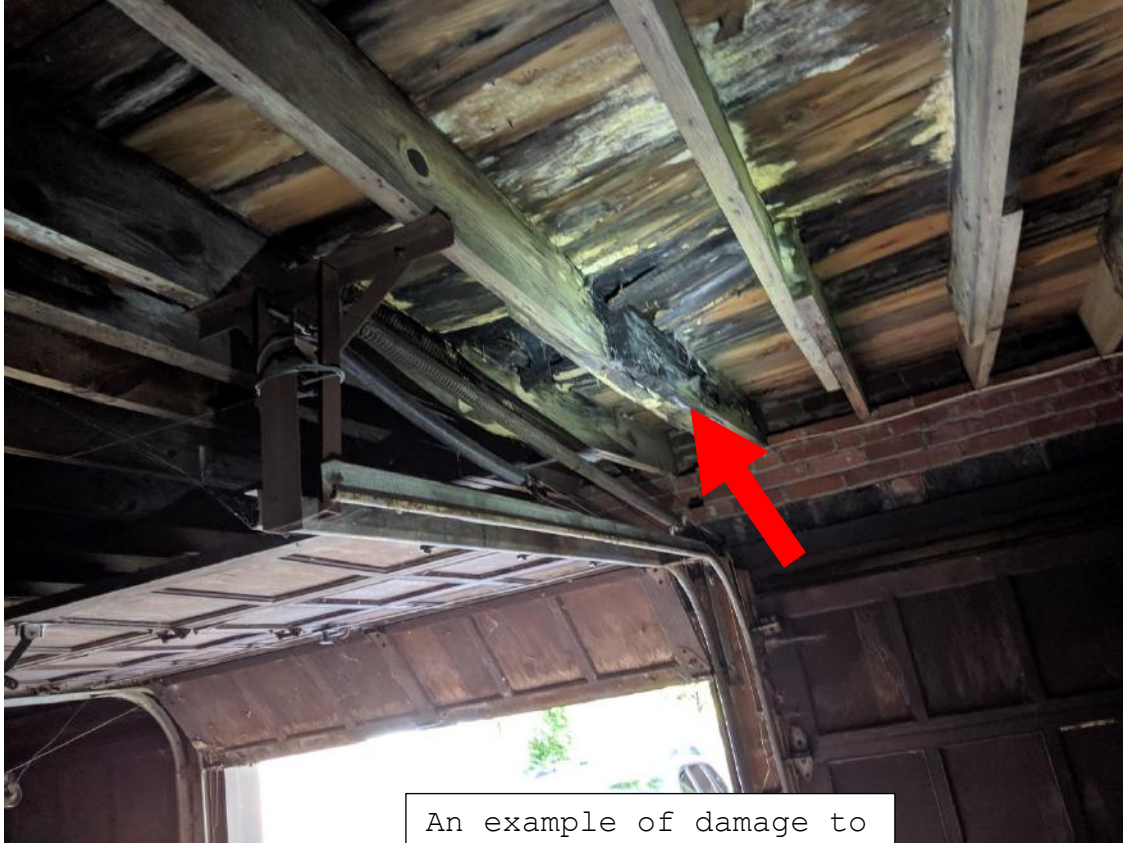
An example of damage to garage roof framing from roof leak.

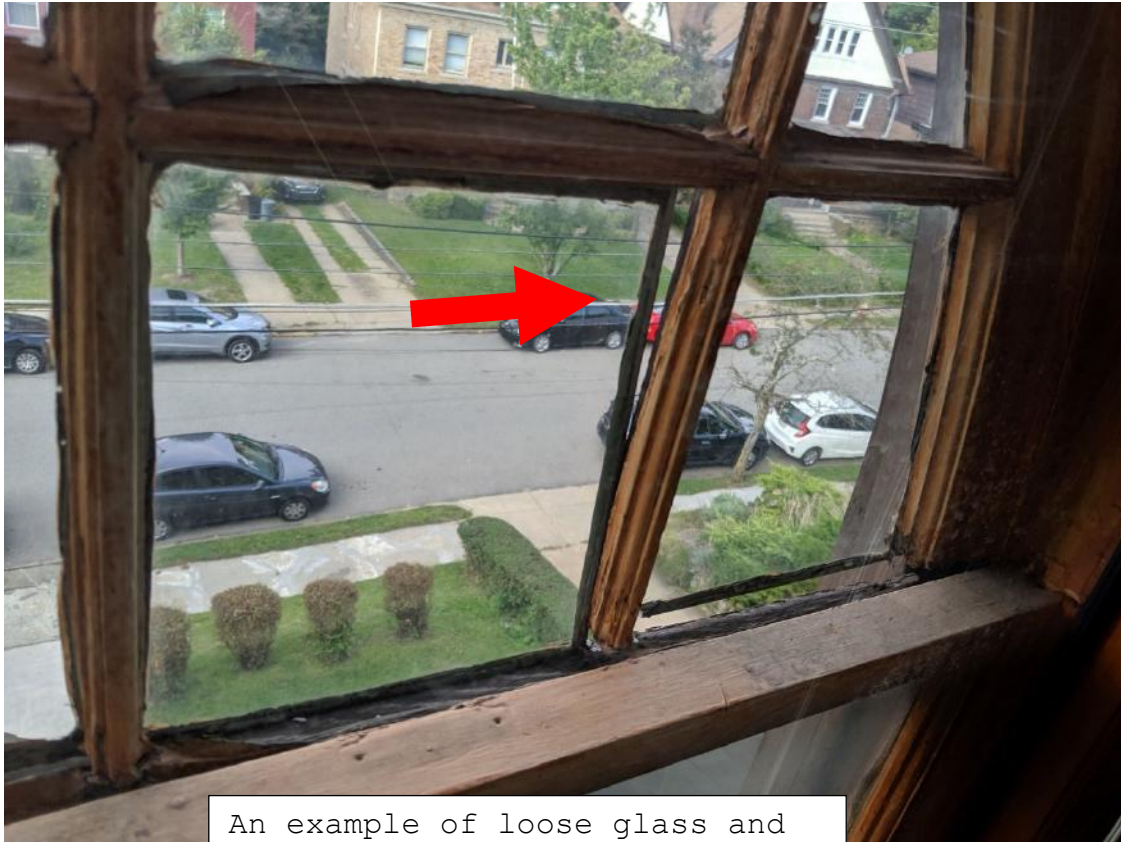
An example of loose glass and rotted wood of third floor window to be replaced.

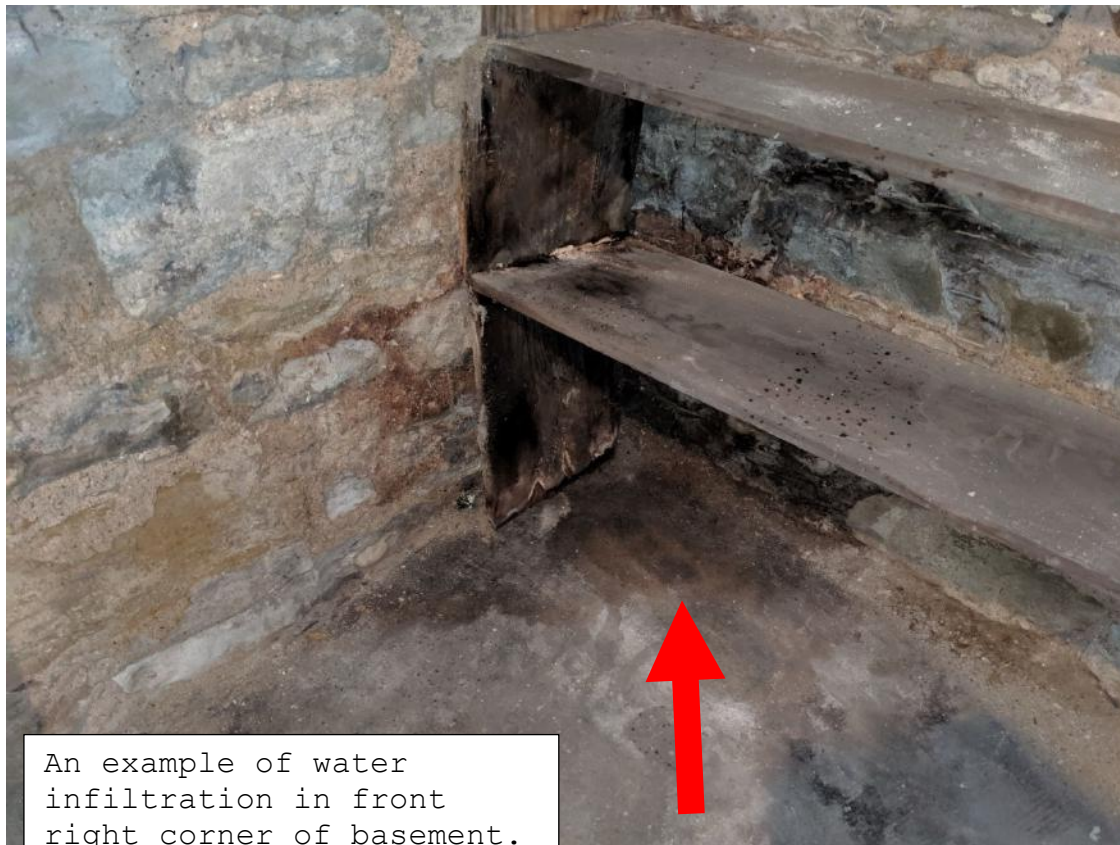
The basement gets wet from water infiltration. Water stains were found on the foundation walls around much of the perimeter of the left, back and right sides of the house. There are water stains on the floor along the left and right foundation walls. The foundation walls were checked with a moisture meter and were found to be wet.

An example of water infiltration in front right corner of basement.

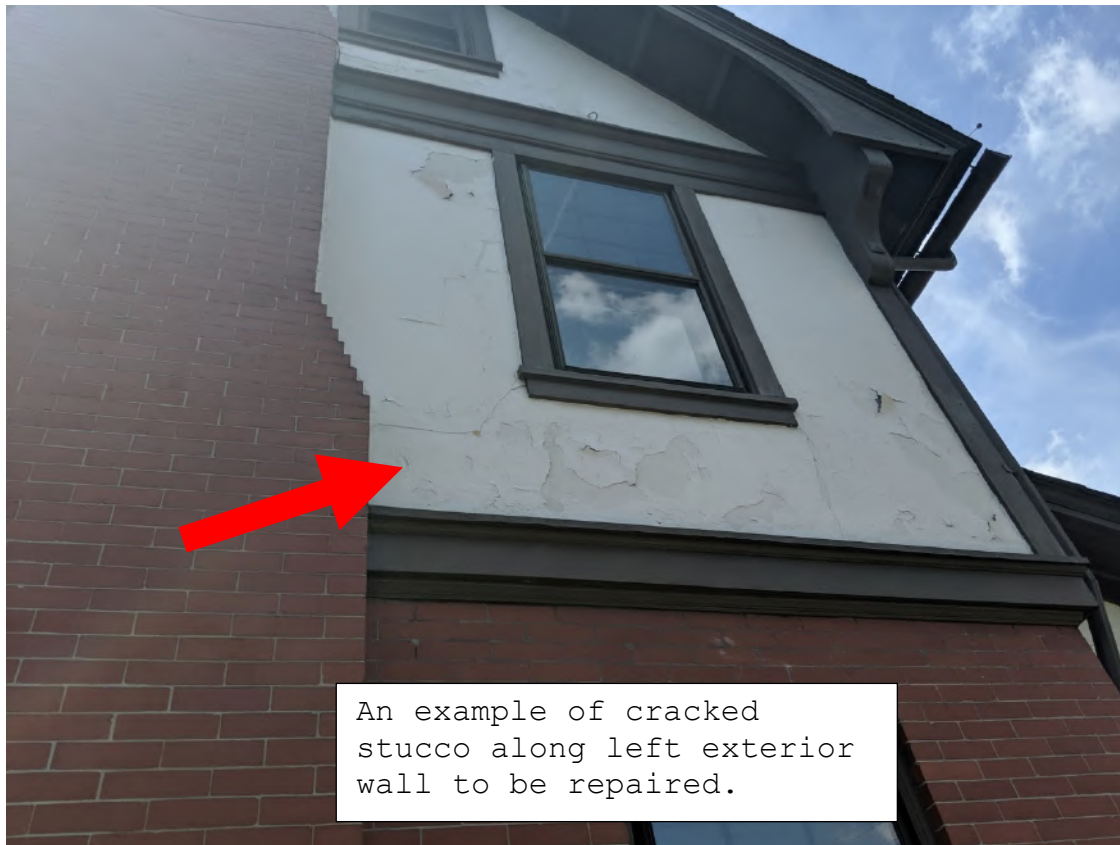
An example of cracked stucco along left exterior wall to be repaired.
