LATOSKY INSPECTION & ENVIRONMENTAL SERVICES, LLC
INSPECTION REPORT

PART ONE

BACKGROUND DATA

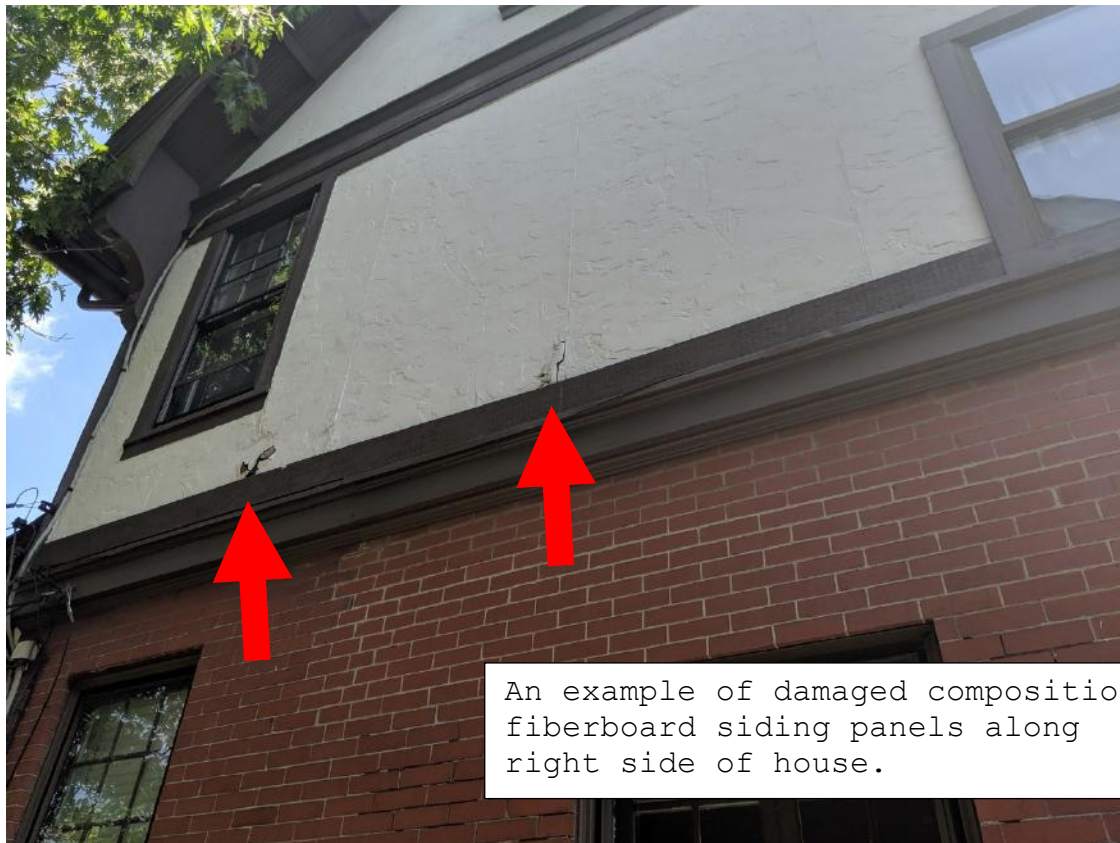
In addition, composition fiberboard faux stucco panels have been installed on the exterior wall along the right side of the house. The siding panels apparently had to be installed because the previous masonry stucco had failed. This siding material was not properly installed and has also failed. The fiberboard panels were not properly flashed and sealed to prevent rainwater runoff from leaking behind the siding. The siding has rotted through in several areas from water leaking behind it into the exterior walls. It is recommended that a qualified professional contractor be called in to replace the exterior siding and evaluate the extent of damage and repair as necessary.

An example of damaged composition fiberboard siding panels along right side of house.

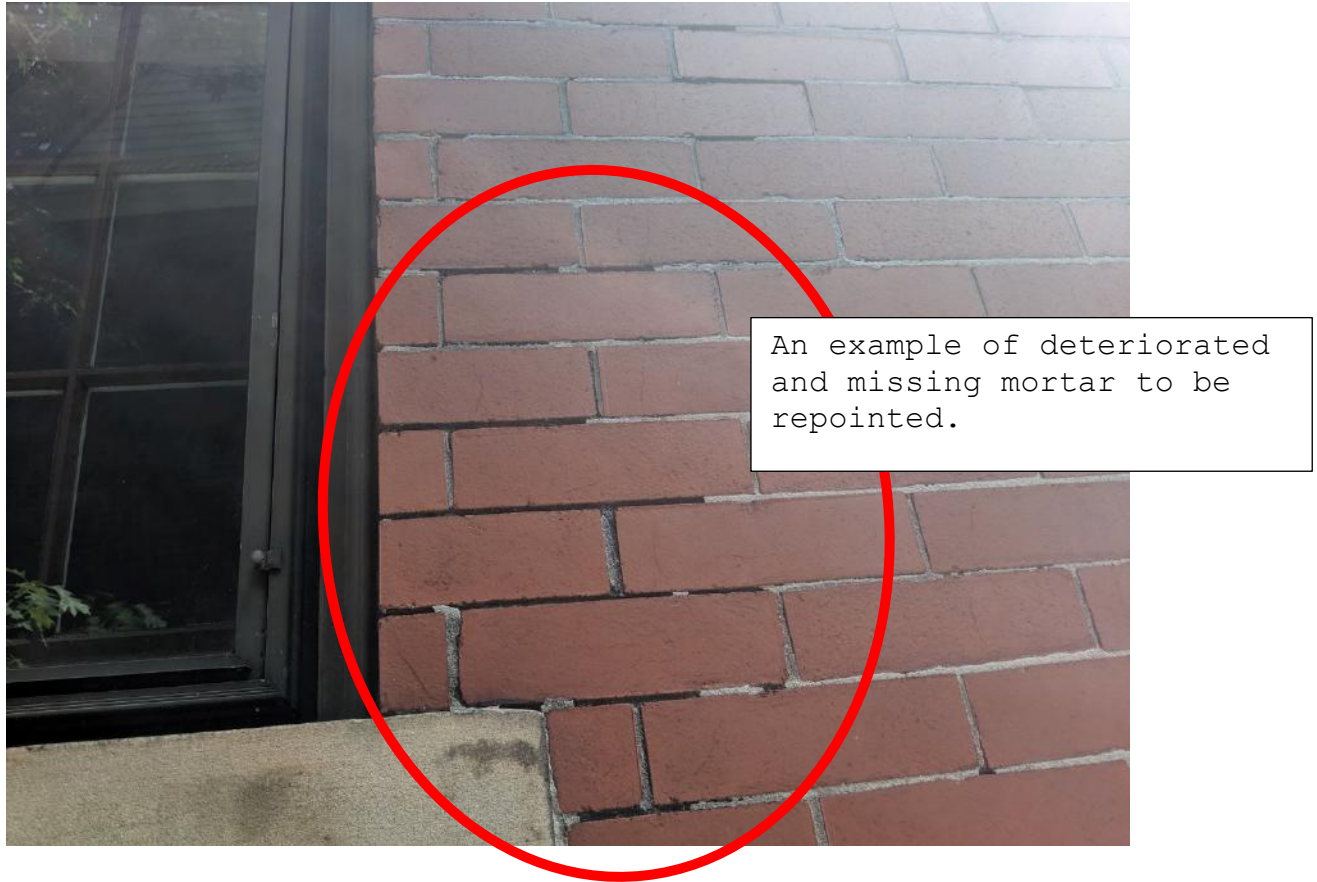
An example of deteriorated and missing mortar to be repointed.

There are areas of deteriorated and missing brick mortar joints around the house that need repair. Have a qualified masonry repairperson into repair and repoint the areas of deteriorated mortar as necessary.

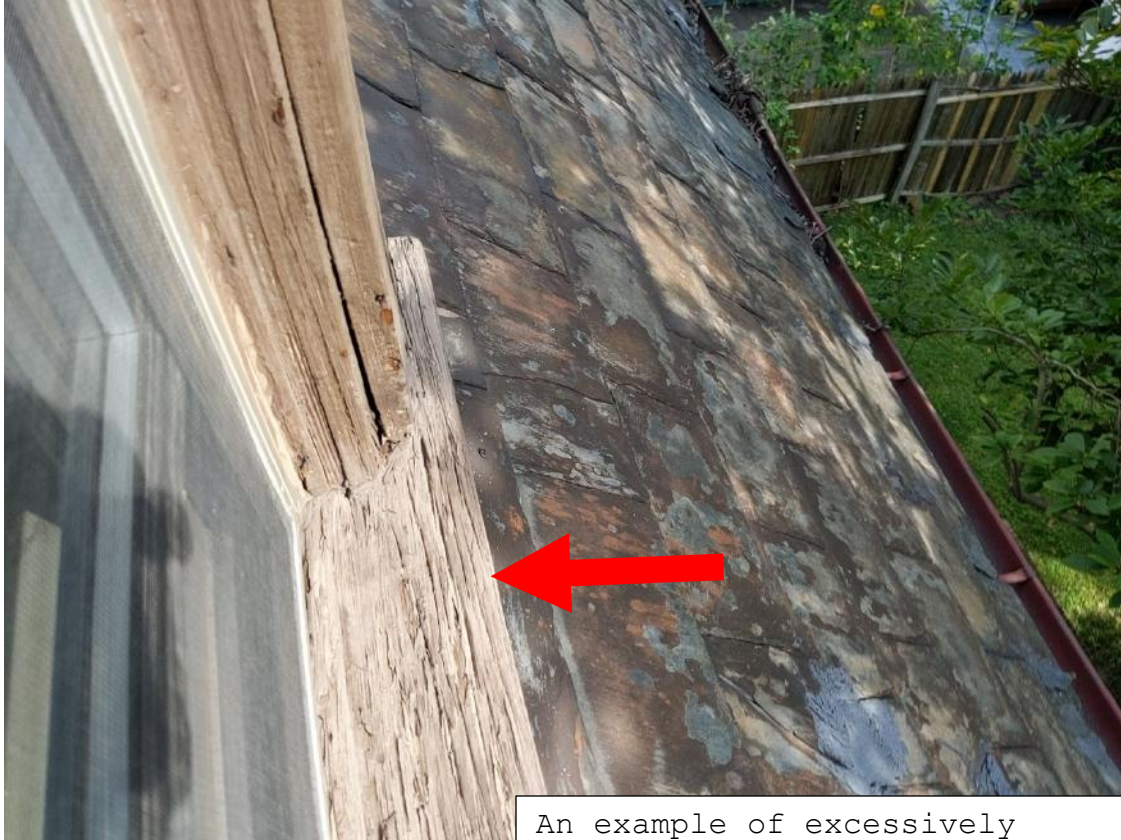
The exterior wood around the house (i.e., soffit and fascia wood, window wood, trim wood, etcetera) has not been maintained in the wood has weathered significantly. The damaged wood should be replaced, and the wood should be repainted as necessary. Have a qualified professional contractor in to repair as necessary.

An example of excessively weathered wood that has not been painted and maintained.

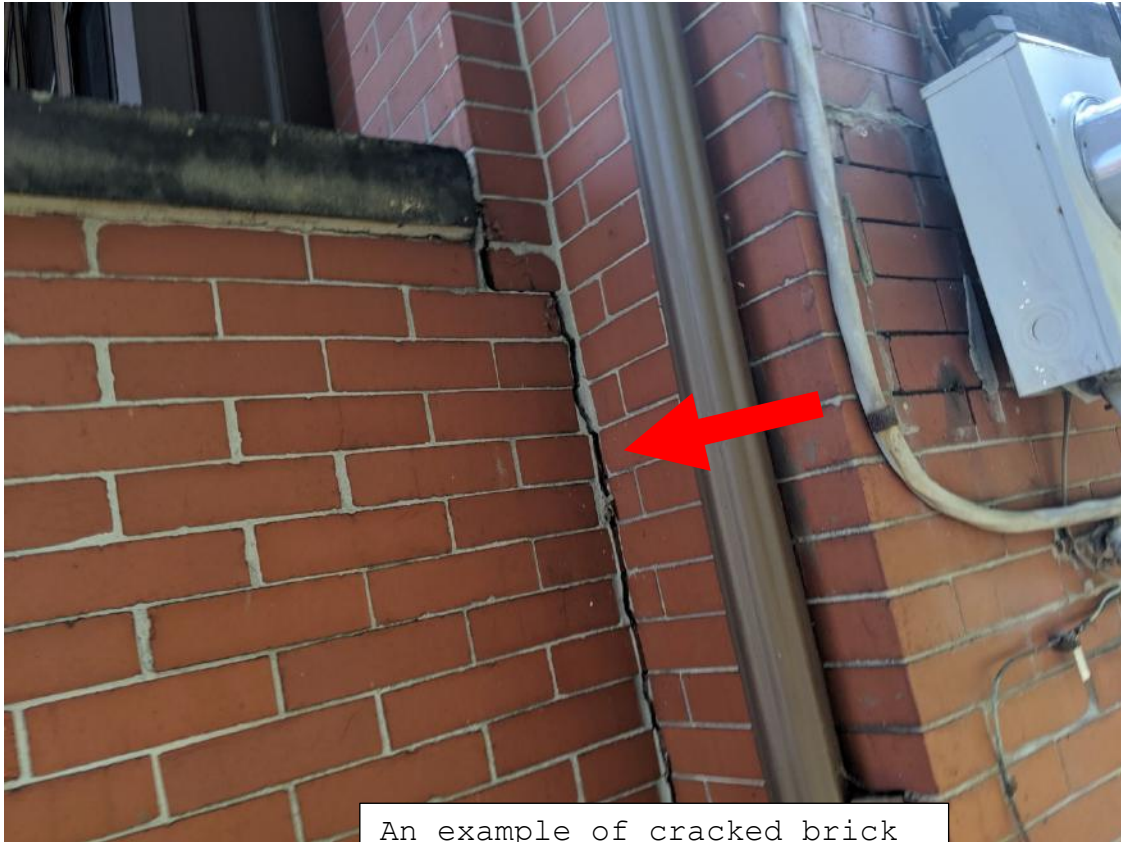
An example of cracked brick mortar joints from settling of front porch structure.

It is recommended that this issue be further evaluated and repaired as necessary by a qualified professional foundation stabilization and repair contractor. The structure may need structural reinforcement with steel piers. Steel piers would be installed below the footing, down to a properly supporting layer of ground such as bedrock. After the piers are installed, the structure will be supported on the piers and not on the potentially inadequate ground currently supporting it.

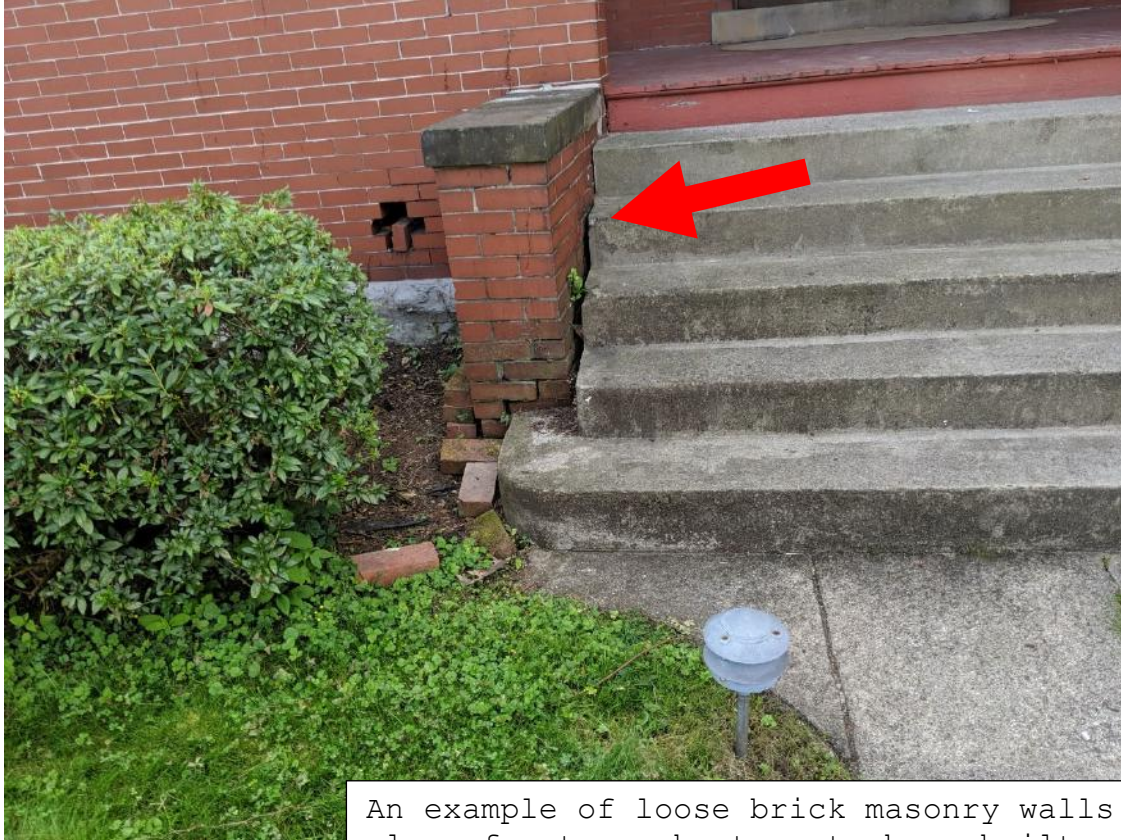
Also, the masonry brick walls along the sides of the front porch steps have deteriorated and are tilting out of place. The walls are loose and endangered falling over. Have a qualified professional masonry repair contractor in to evaluate and repair or rebuild the walls as necessary.

An example of loose brick masonry walls along front porch steps to be rebuilt.

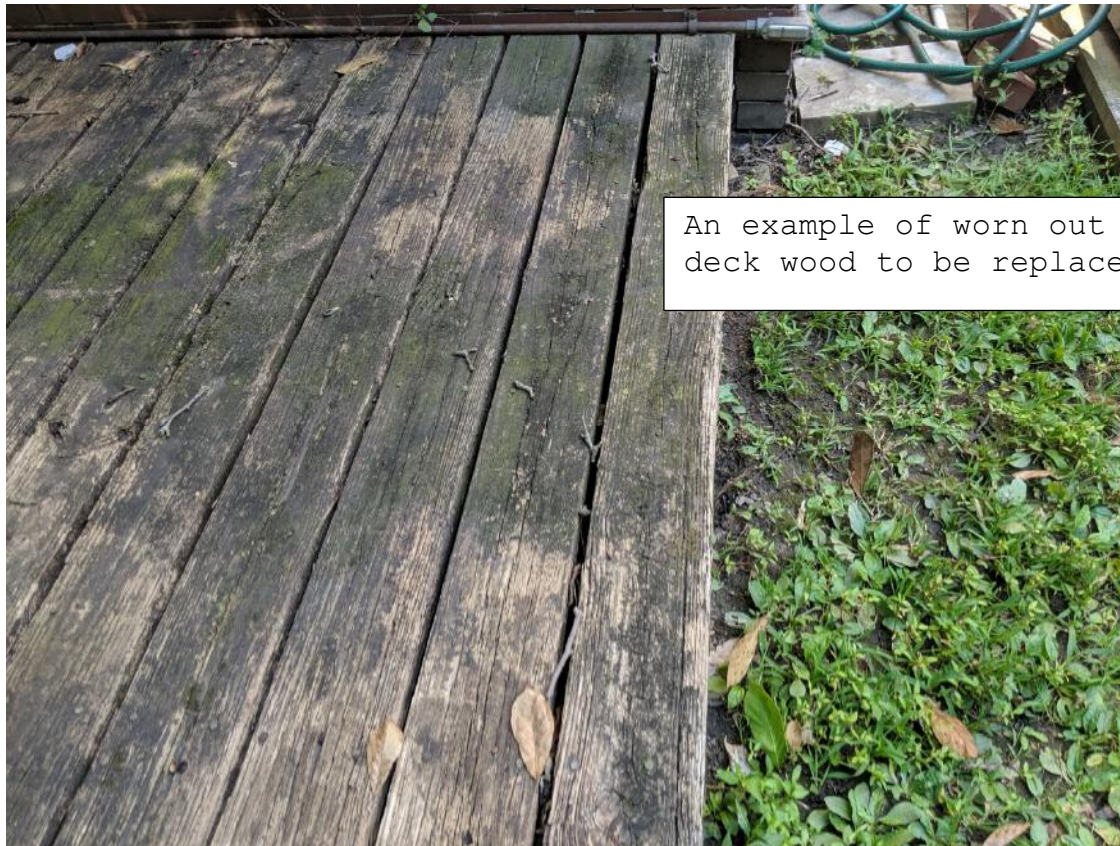
The deck wood along the back of the house has not been maintained and the wood has weathered and deteriorated significantly. The wood is cracked and splintering. The wood should be replaced as necessary. As discussed at the inspection, the door hatch in the deck to the basement stairway poses a potential full hazard. Have a qualified professional contractor in to replace the deck.

An example of worn out deck wood to be replaced.
