LATOSKY INSPECTION & ENVIRONMENTAL SERVICES, LLC
INSPECTION REPORT

PART ONE

BACKGROUND DATA

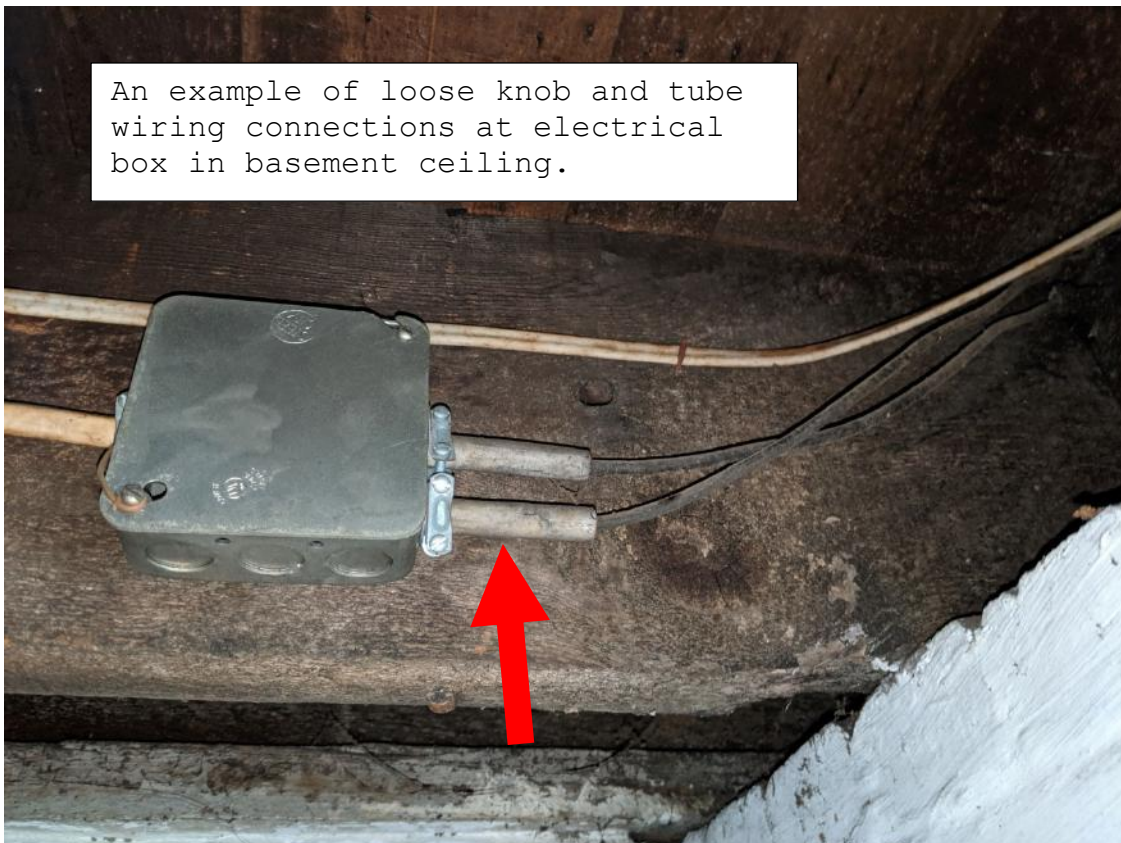
An example of loose knob and tube wiring connections at electrical box in basement ceiling.

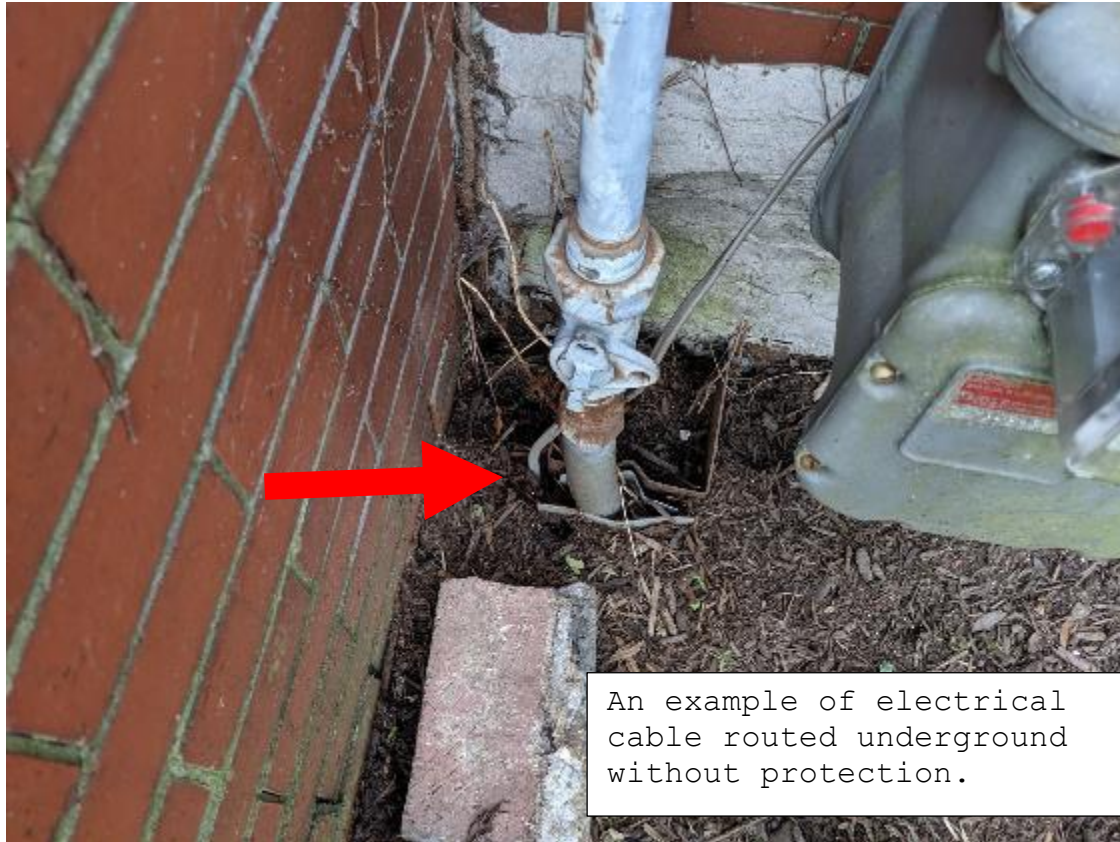
The electrical outside along the front of the house by the gas meter is not properly protected from damage where the cable is routed underground.

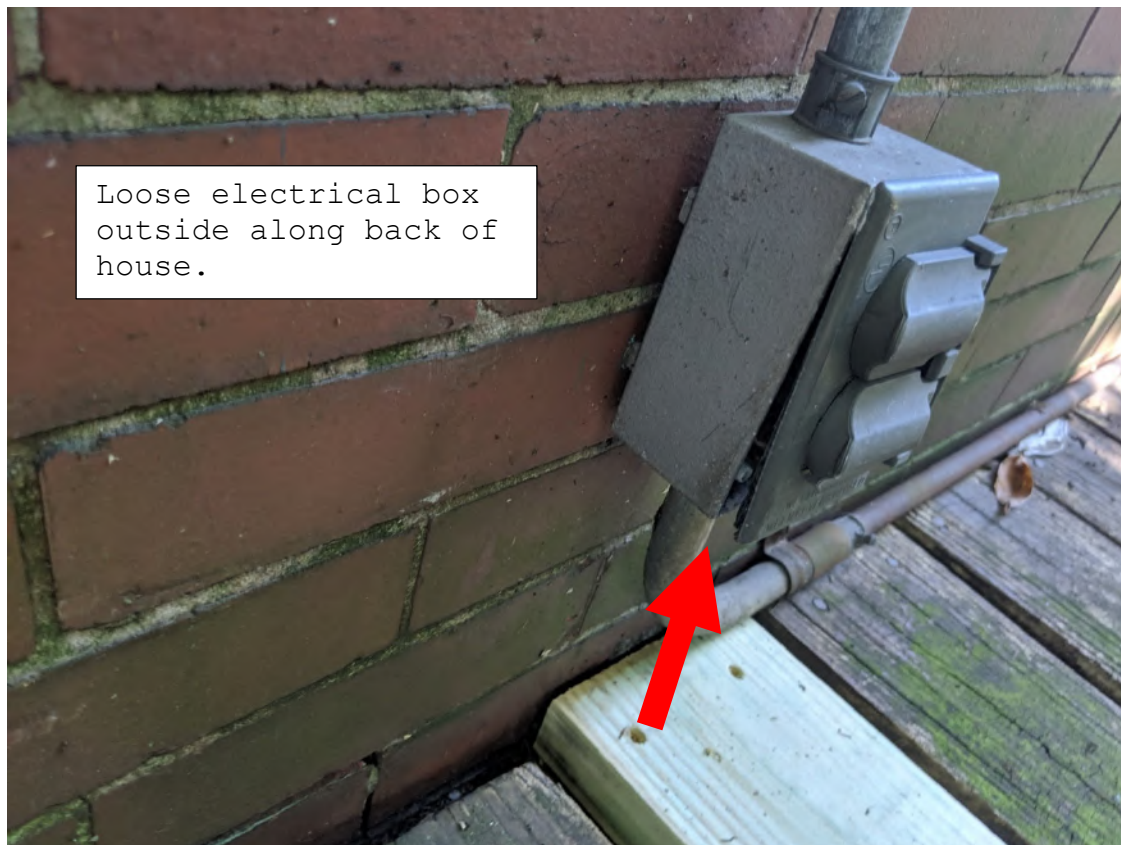
The electrical box cover and receptacle outside along the back of the house are loose. Have repaired as necessary to prevent a potentially dangerous loose open electrical connection.

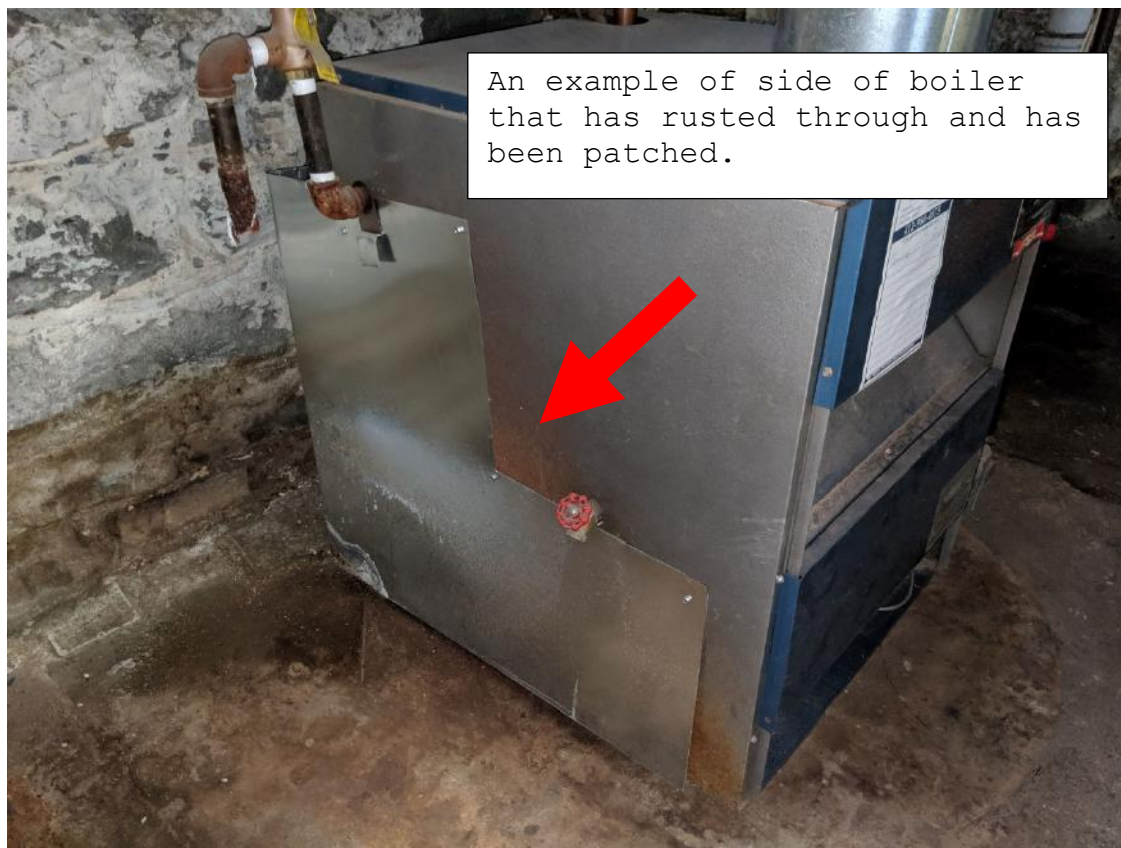
In addition, note that the side of the boiler has rusted out apparently from the pressure relief valve along the side of the boiler leaking. The rusted through section of the boiler has been temporally patched with a piece of sheet metal. Have the boiler repairperson further evaluate integrity of this repair.

Note that the boiler is approximately 36 years old. This puts this unit beyond its statistically expected life span of 25 to 30 years.

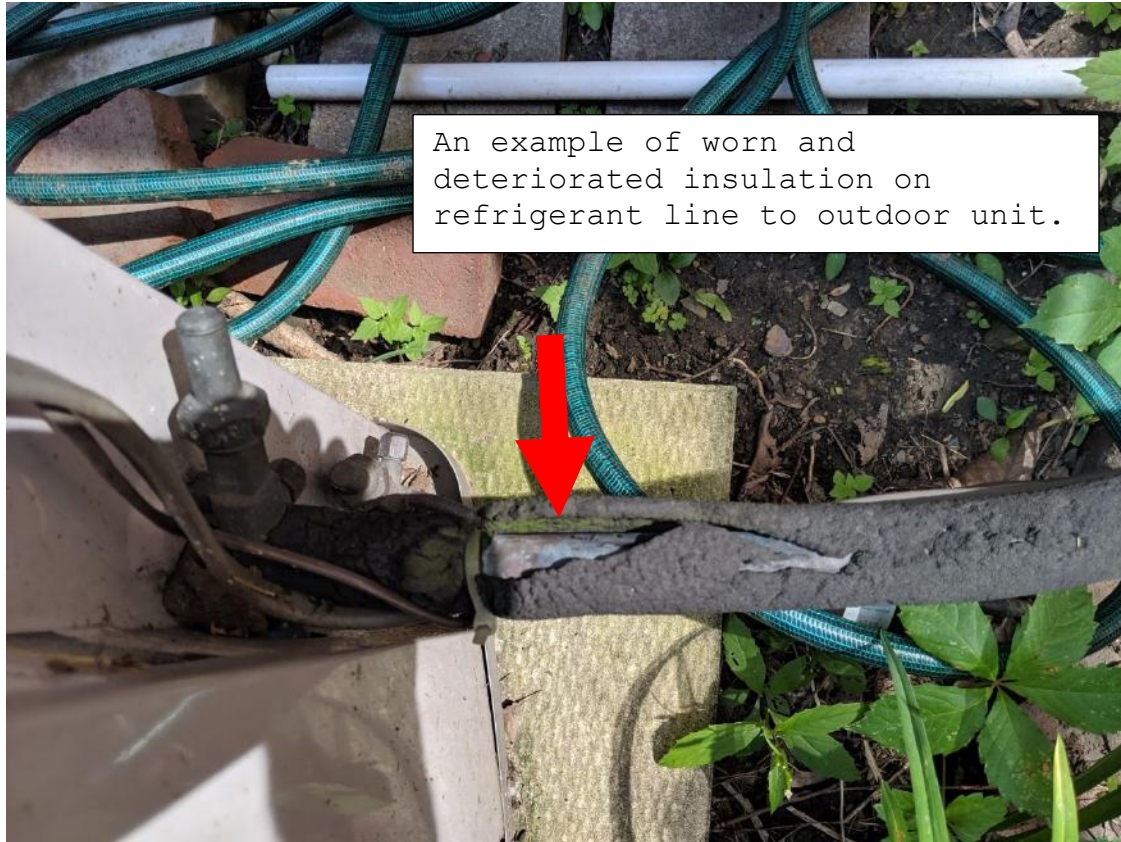
Note that the insulation on the air conditioning refrigerant line for the outdoor unit is deteriorated and missing. The missing insulation should be replaced as a necessary.

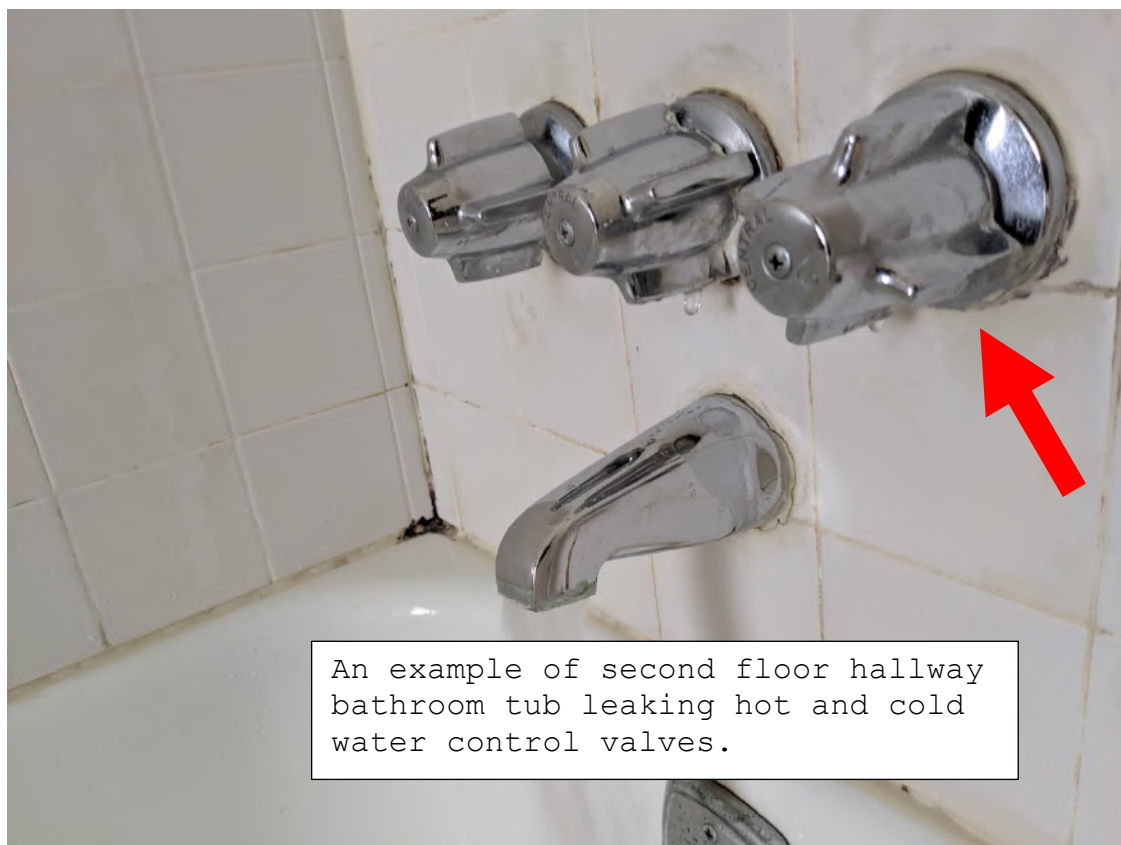
The second floor hallway bathroom tub hot and cold water control valves leak around the bases of the valves when the water is on. Have repaired or replaced as necessary to stop water from leaking behind the wall.

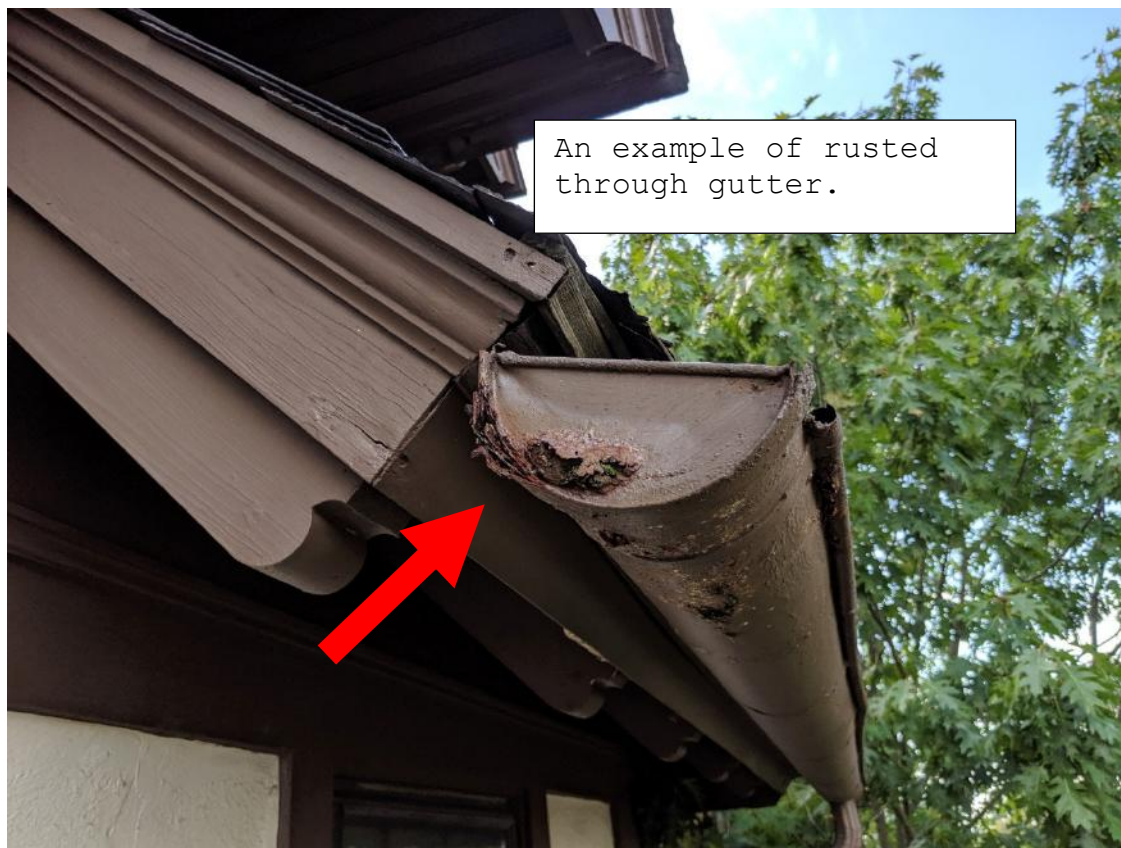
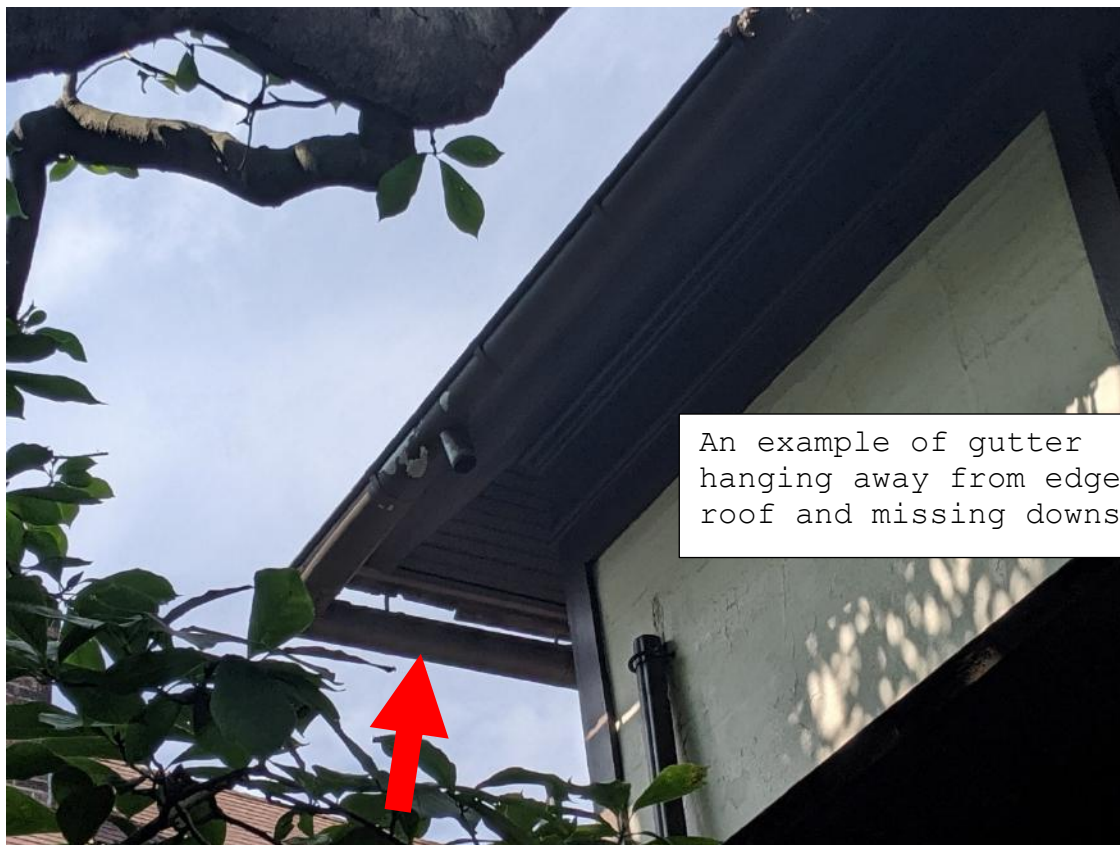
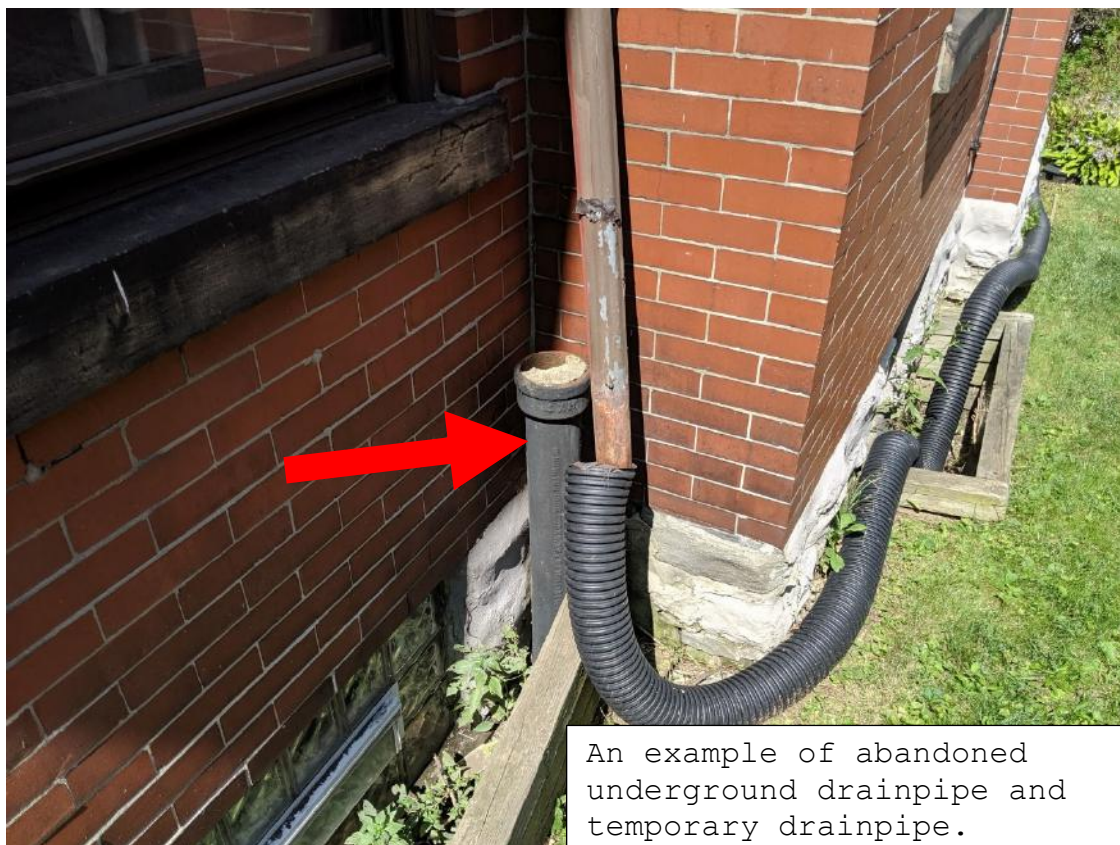
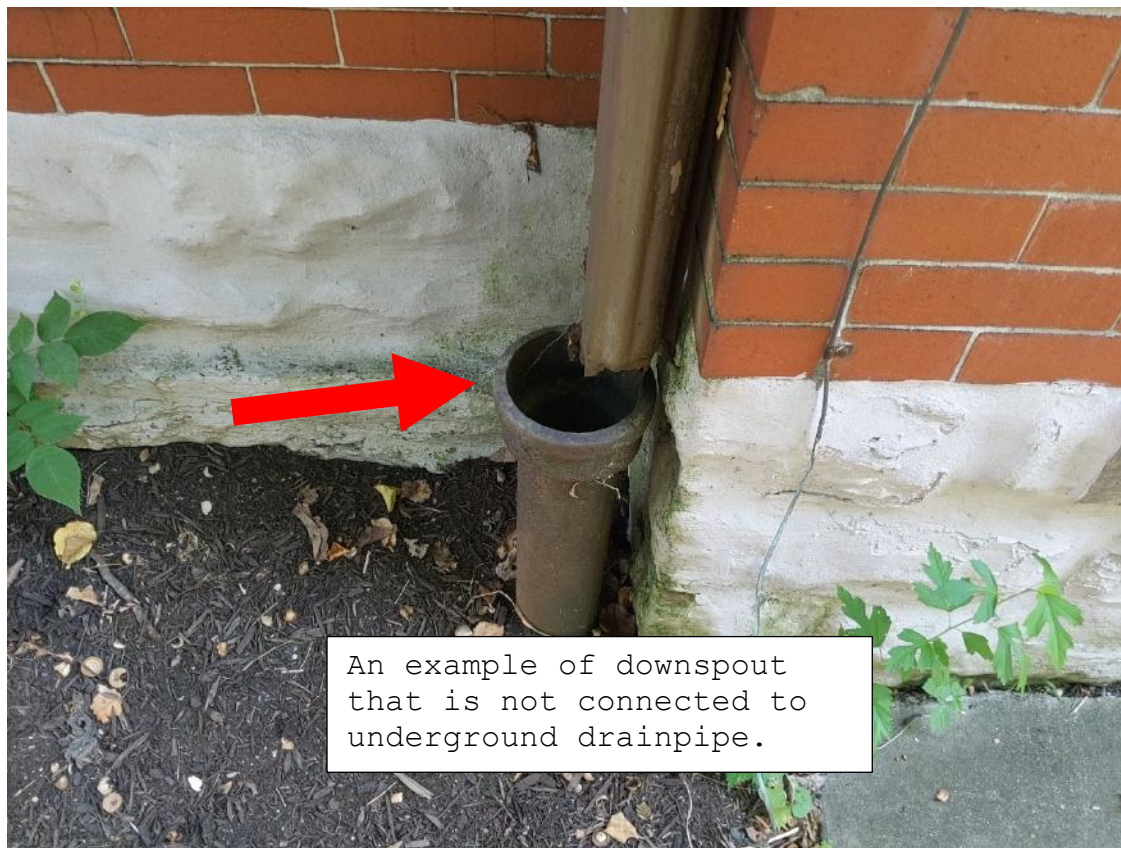
The gutters and downspouts around the house have rusted through and leak. The gutters and downspouts need replaced. Consult with the roofer about replacement. Note that the cost to replace the gutters and downspout is expected to be significant.

Also, the downspout underground drainpipe along the left side of the house has been abandoned and a temporary drainpipe extension has been added to the end of the downspout. This extension is not properly draining roof rainwater away from the house and is a primary cause of the water infiltration along the left foundation wall.

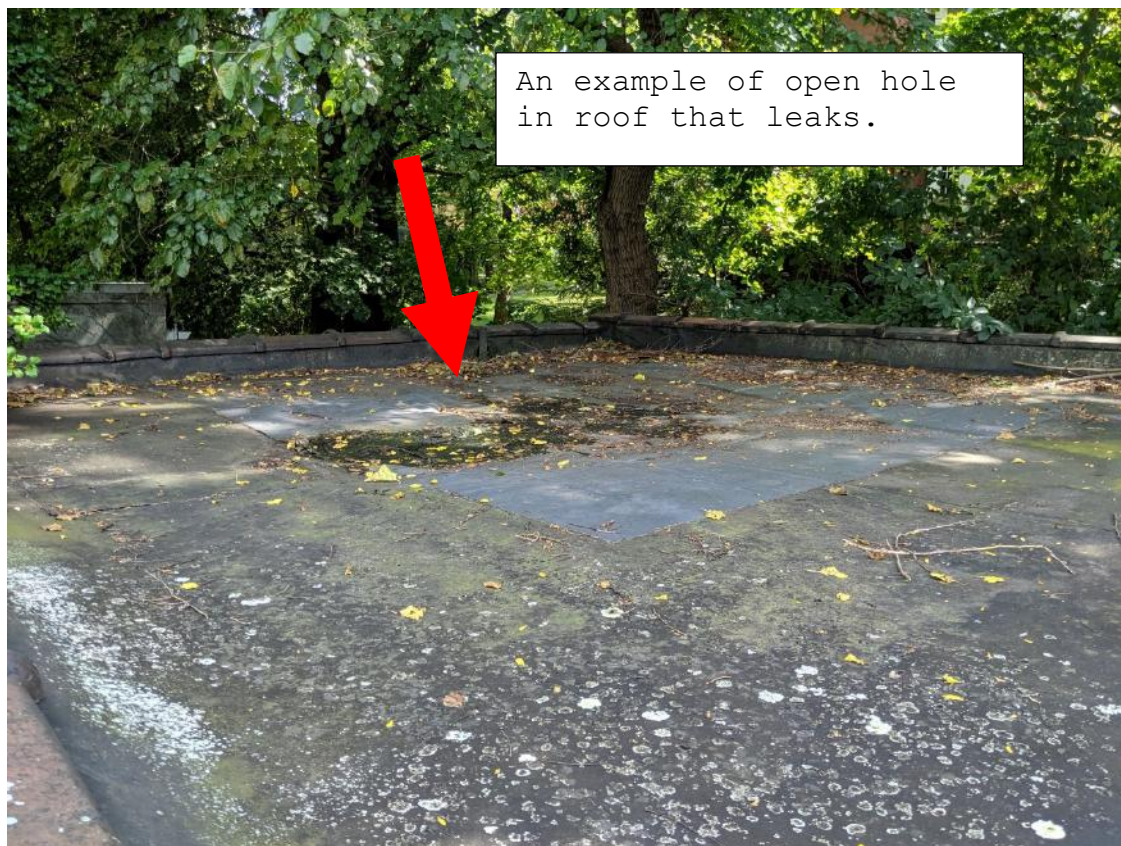
The garage roof has failed. there are holes in the roof and the roof leaks in multiple areas. There is damage to the garage roof framing from the roof leaking. The roof and the damage to the wood framing should be replaced as necessary by a qualified professional roofer.

Also, note that there is suspected mold on the garage ceiling and store items throughout the garage from excessive water infiltration from the roof leaking.

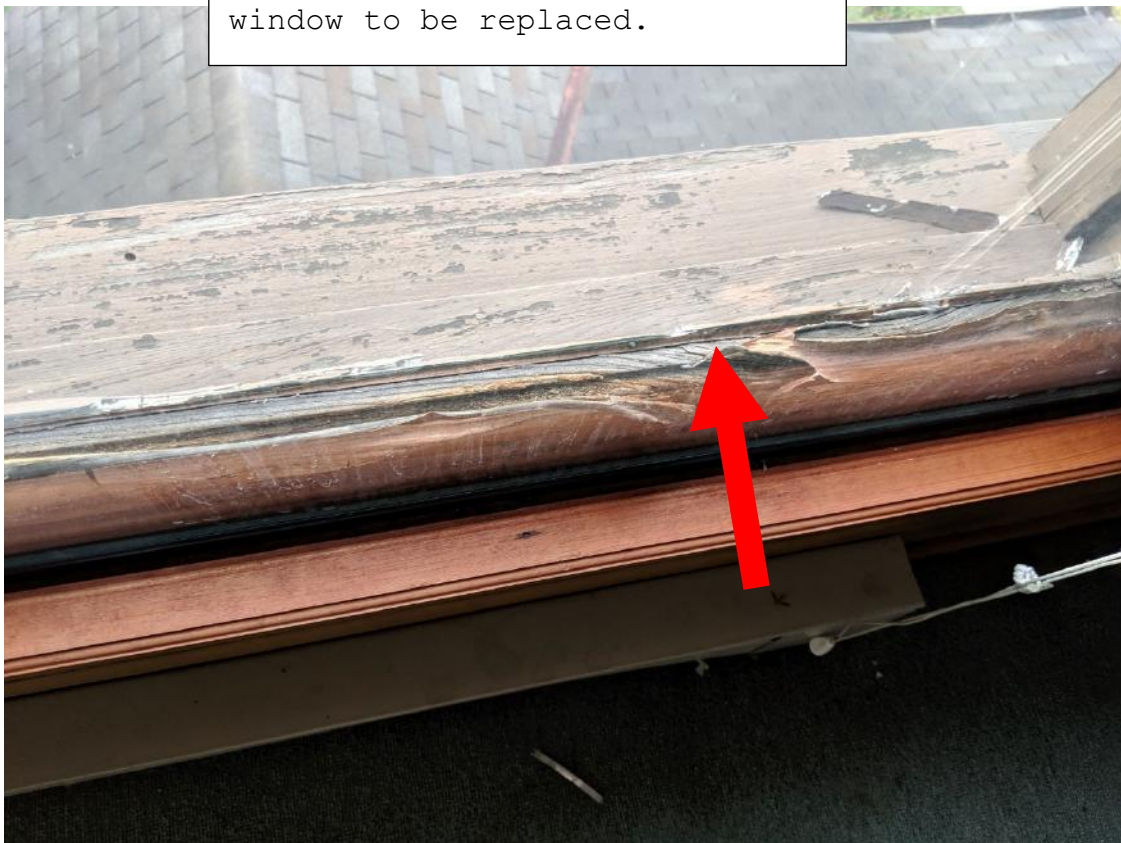
An example of loose glass and rotted wood of third floor window to be replaced.

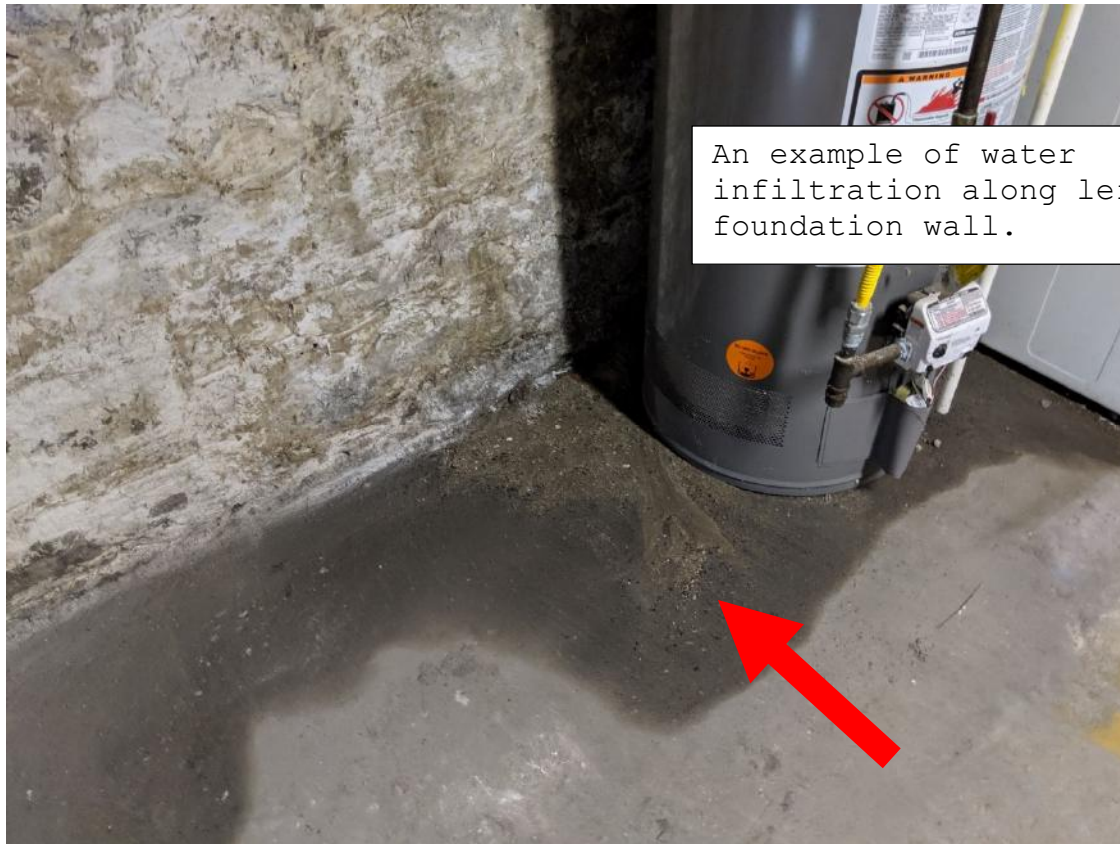
The basement gets wet from water infiltration. Water stains were found on the foundation walls around much of the perimeter of the left, back and right sides of the house. There are water stains on the floor along the left and right foundation walls. The foundation walls were checked with a moisture meter and were found to be wet.

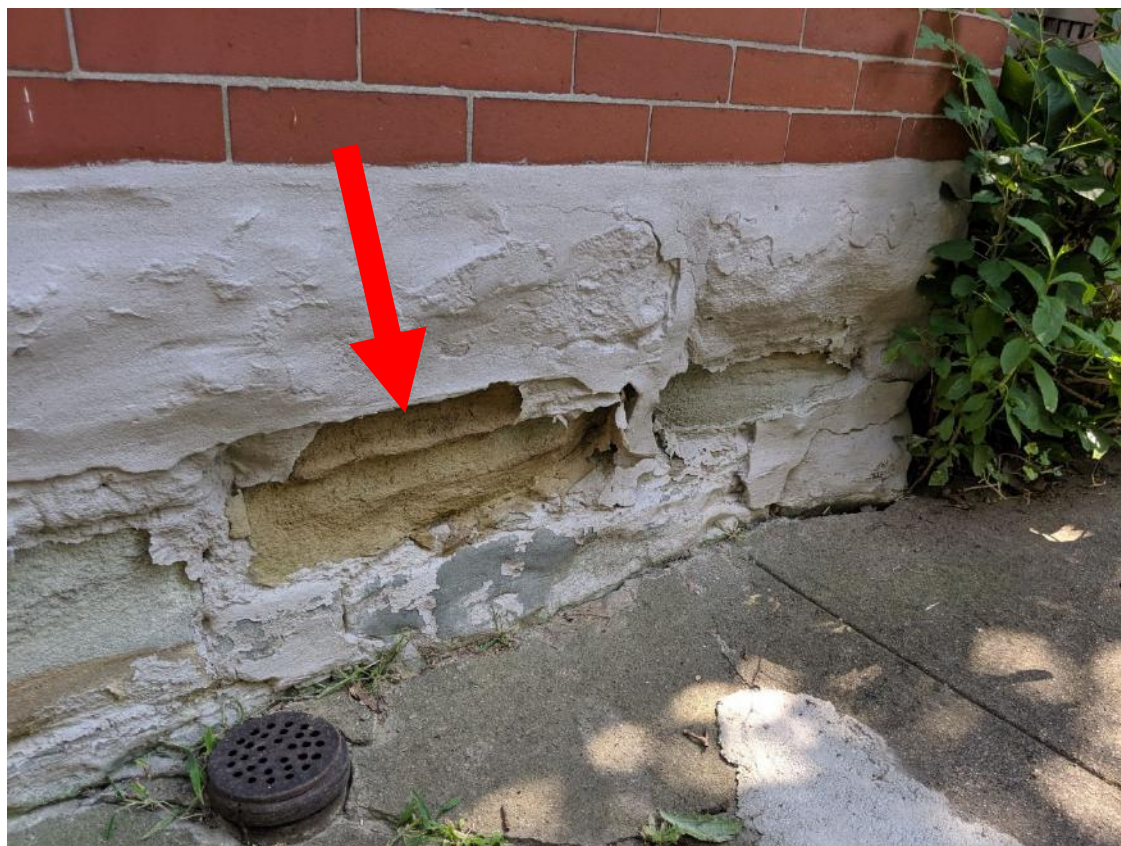
Also note that there are stones in the foundation walls along the left and right side of the house that are deteriorated and need repair. Have a qualified professional masonry repair person into repair the deteriorated foundation wall stones.

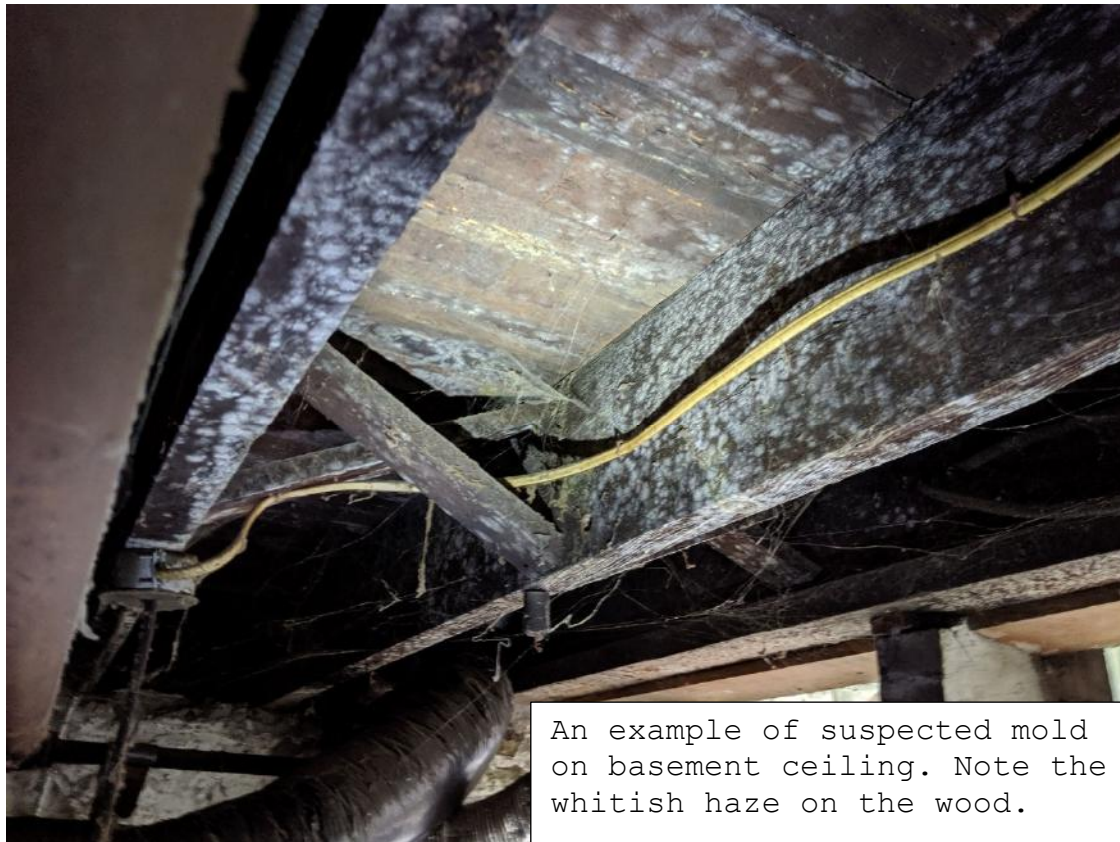
A basement with this extent of dampness facilitates the growth of mold. Suspected mold growth was observed on ceiling and wall surfaces throughout the basement, especially in the basement laundry area. Molds affect individuals differently. Laboratory testing would be necessary to identify the different types of mold. Environmental Protection Agency (EPA) guidelines state that "visible mold, mold damaged materials, and moldy odors should not be present" in a healthy home. For authoritative further information regarding mold in the home, refer to the following EPA web site:

Generally, the EPA suggests that the mold be removed and that the water issues that cause the mold be eliminated.

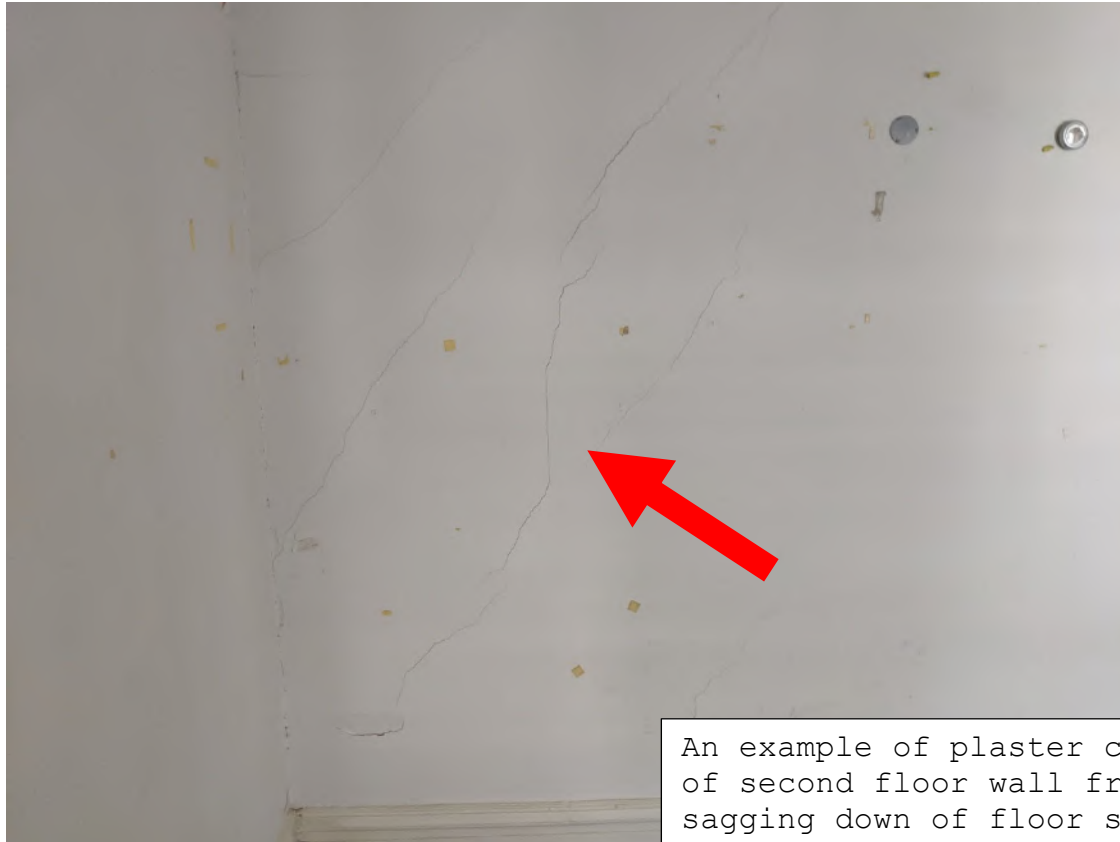
The second floor back room wall does not appear to be properly stacked above the first floor center support wall below. The wall and floor structure in this area has sag downward. There is cracking through the second floor wall perpendicular to exterior wall along the back of the house from this sagging down of the floor structure. Also, there are cracks in the first floor ceiling below. It is recommended that a qualified professional structural repairperson be called in to further evaluate this issue and to provide the necessary repairs.

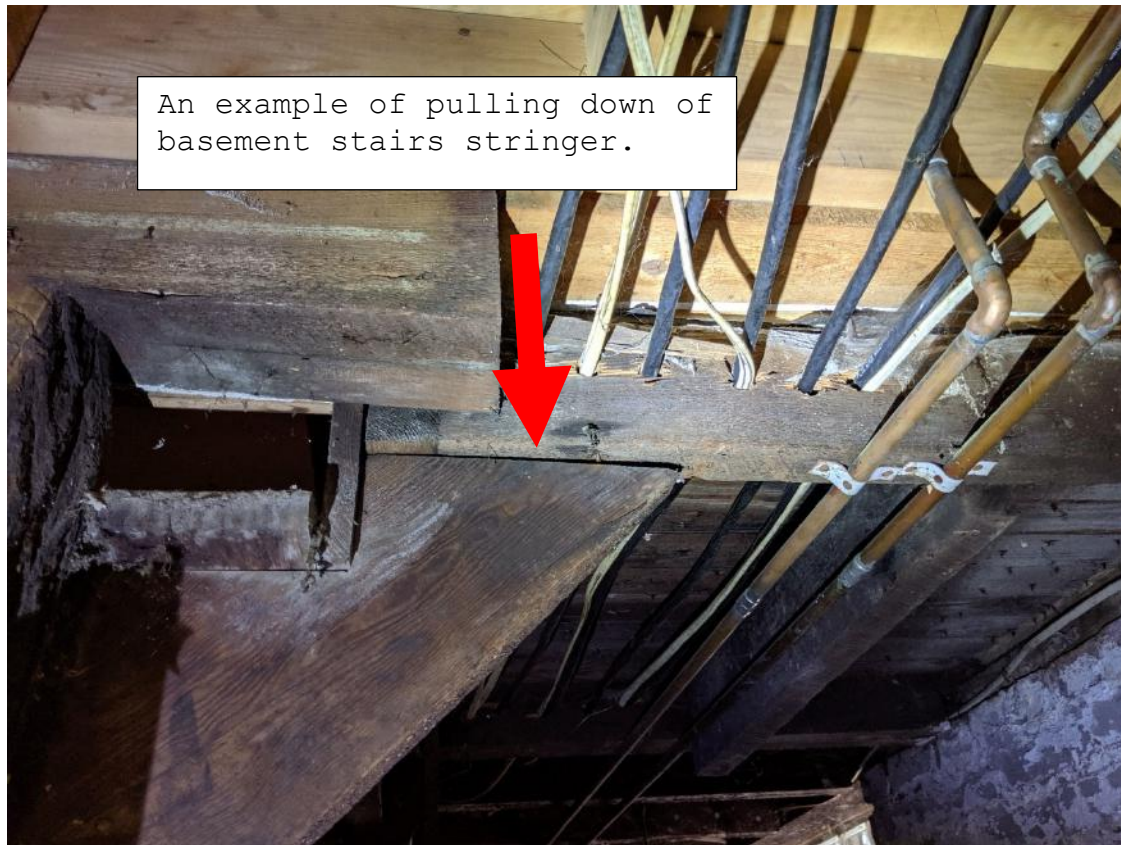
The top of the basement stairs were attached to the ceiling wood framing with nails. The nails are loosening, and the stairs have pulled downward from there attachment to the ceiling wood framing. Have repaired as necessary to prevent a potential collapse of the stairs.

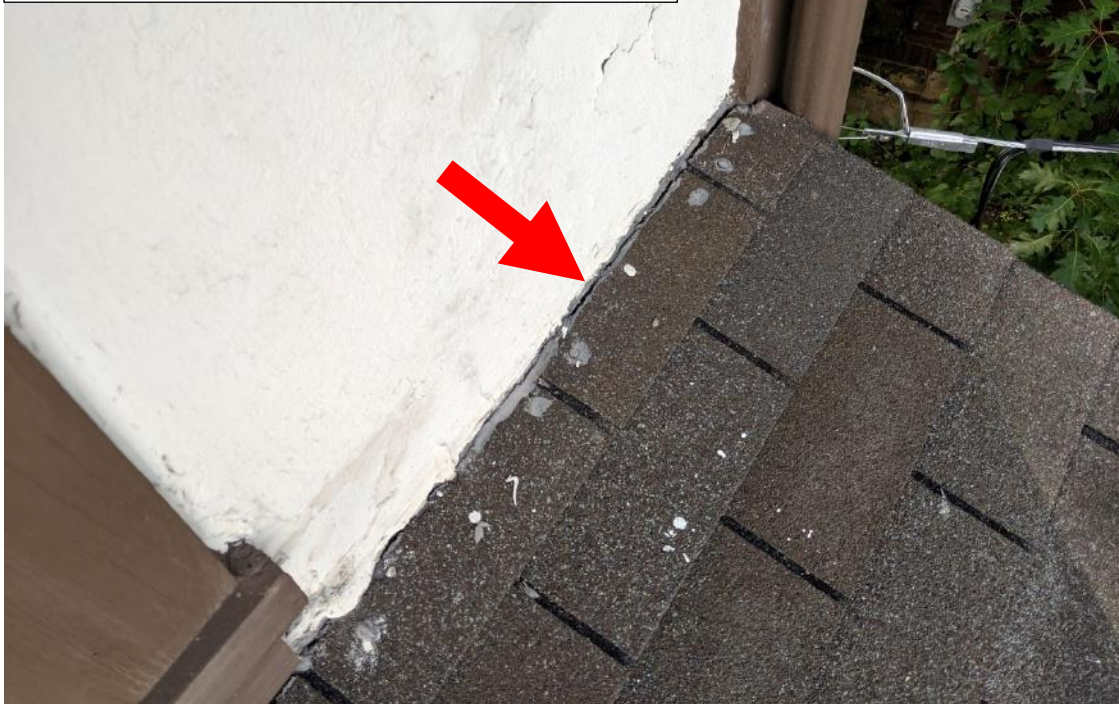
An example of gap between front wall of house and porch roof from porch structure settlement.

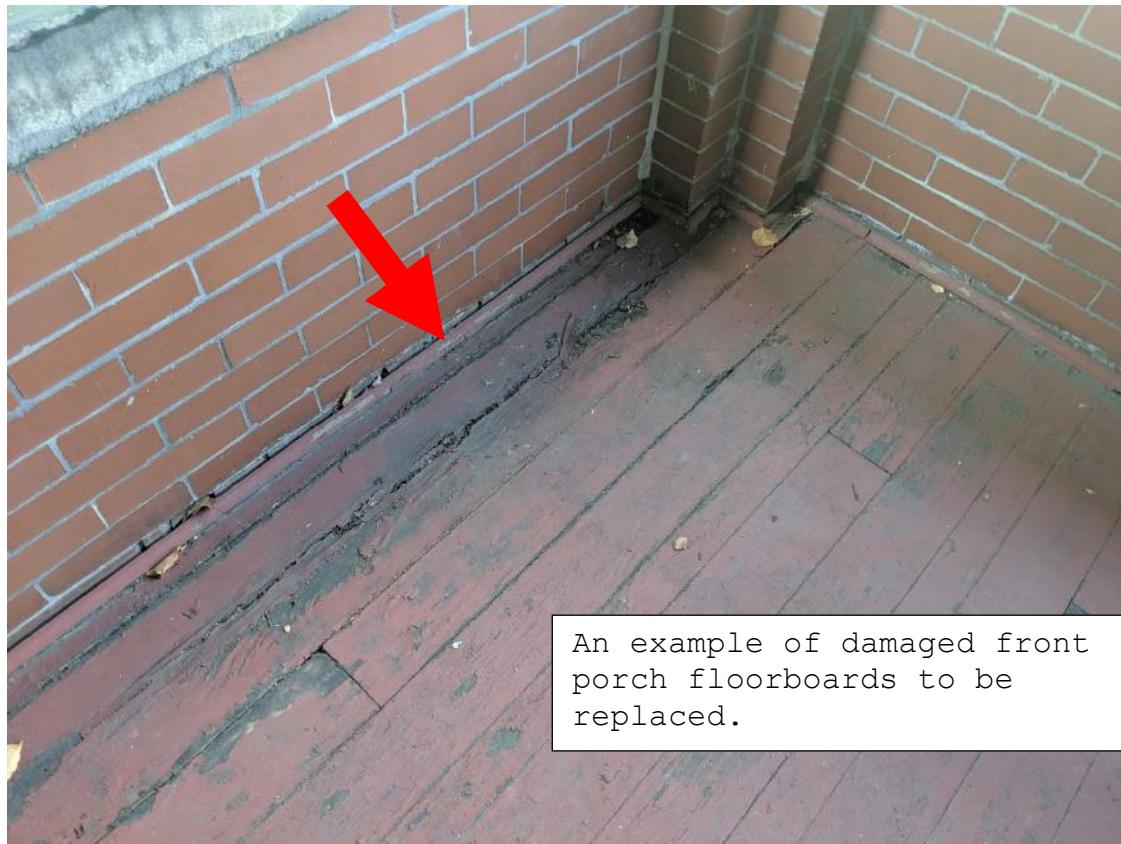
Also, note that the wood flooring along the right side of the front porch has weathered and deteriorated. The damaged wood should be replaced as necessary.

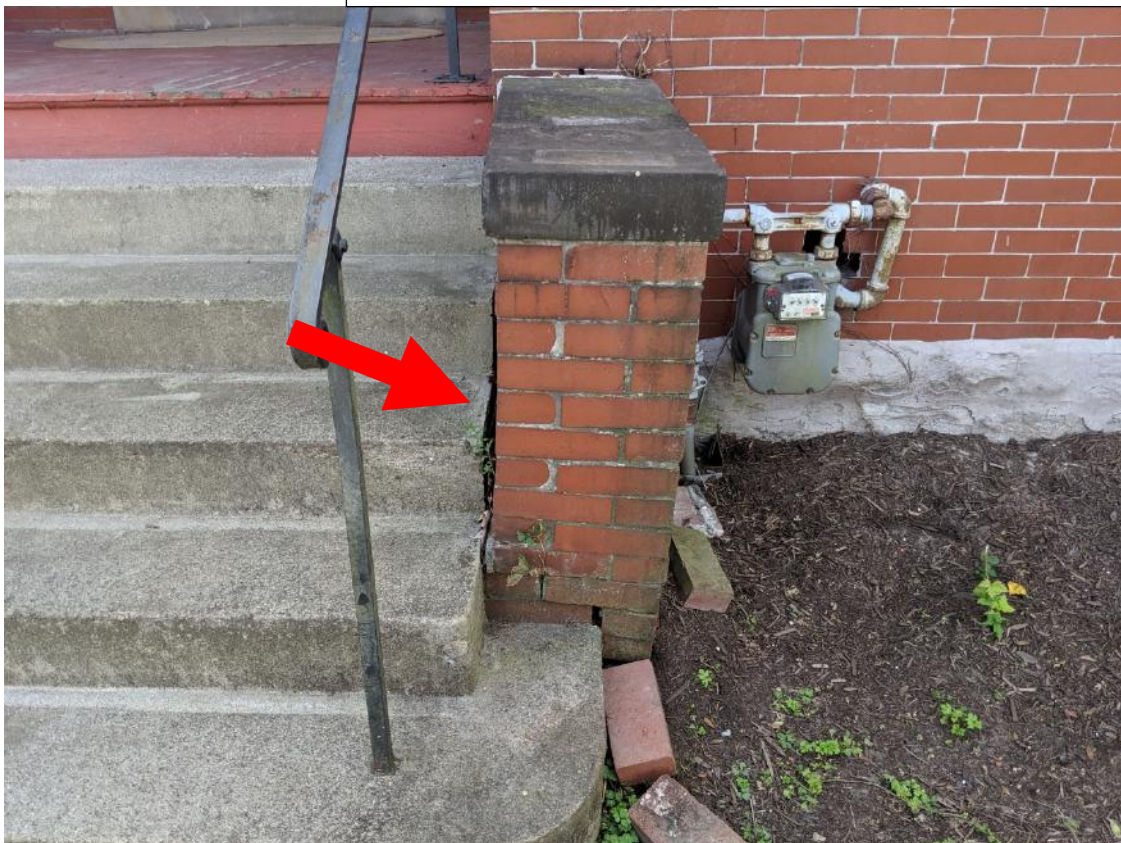
An example of loose brick masonry walls along front porch steps to be rebuilt.

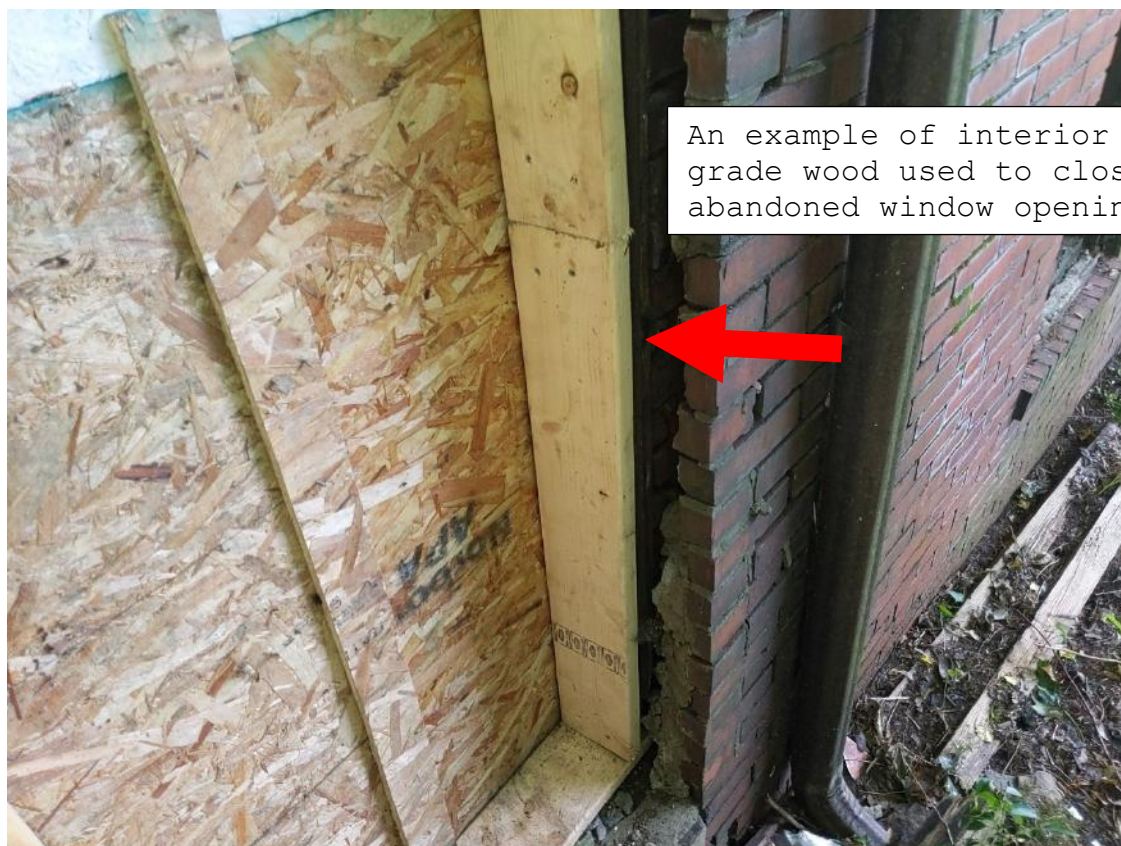
The garage left wall window has been temporarily closed in with interior grade framing materials. The abandoned window opening should be closed with exterior grade materials.

The lintel above the garage door openings should be cleaned free of rust and repainted and sealed as necessary.

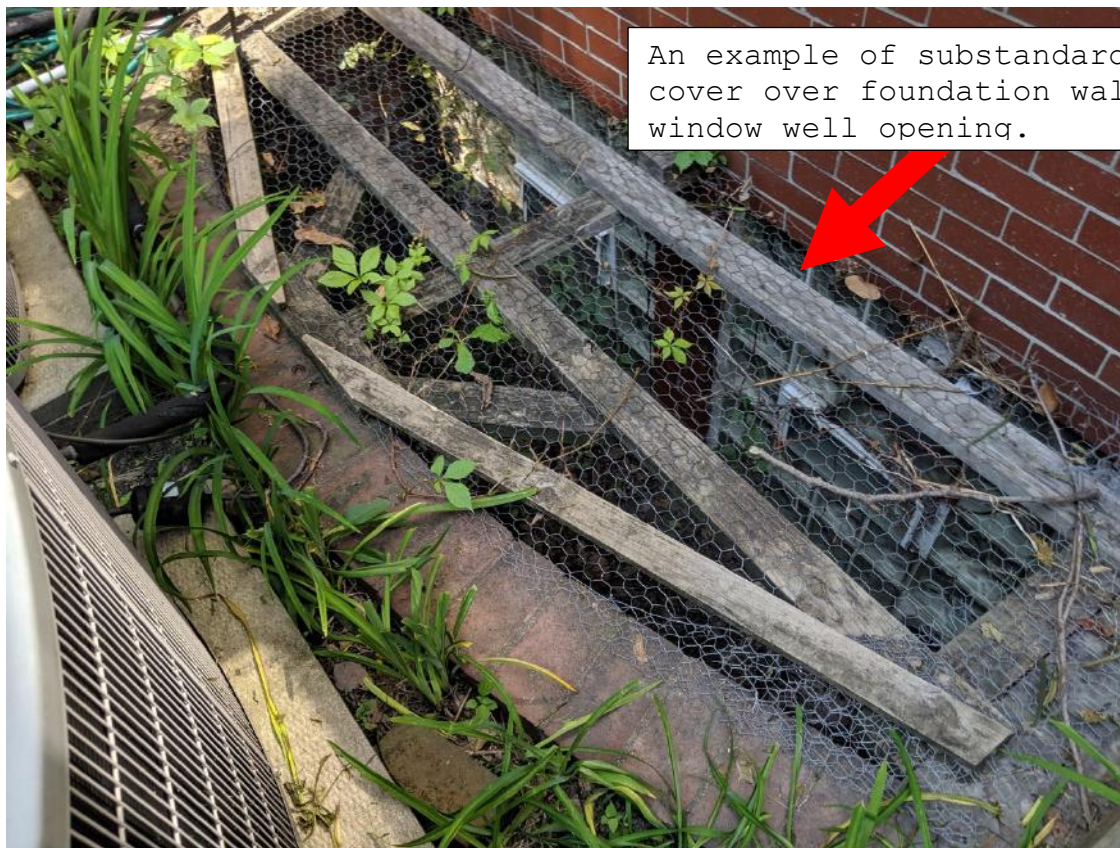
The basement foundation wall window well along the left side of the house is caving in and needs rebuilt. Have rebuilt as necessary.

The wire fencing over the foundation window well along the back of the house is not structurally sound. A person could fall into the window well. Have properly covered as necessary.

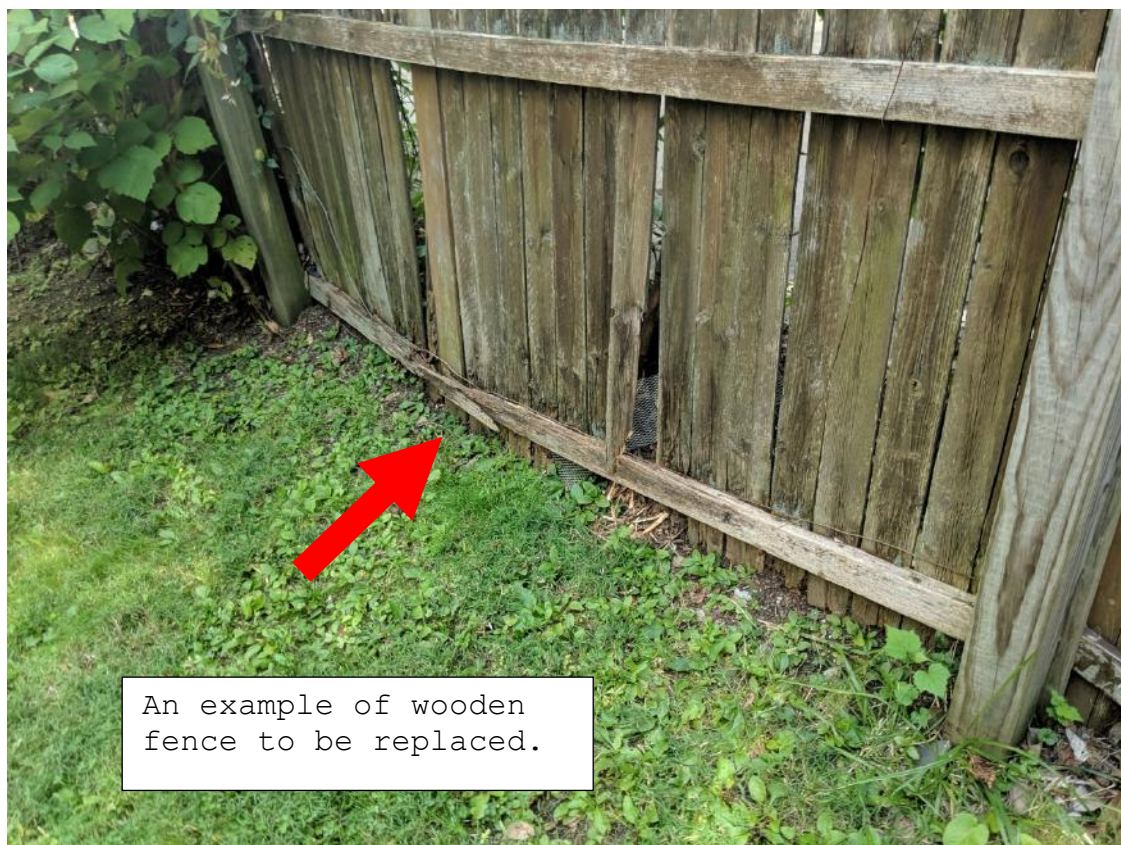
The wood privacy fence along the backyard has rotted and deteriorated wood and the fence is tilting over along the left side neighboring property. Have the fence replaced as necessary.
